Access Compliance Report

Public Rights-of-Way

(Curb Ramps)

| Intersection ID: 49126 | Main Street: CARLOTA_CT | Cross Street: LEGOLAS_LN | Location: NW |

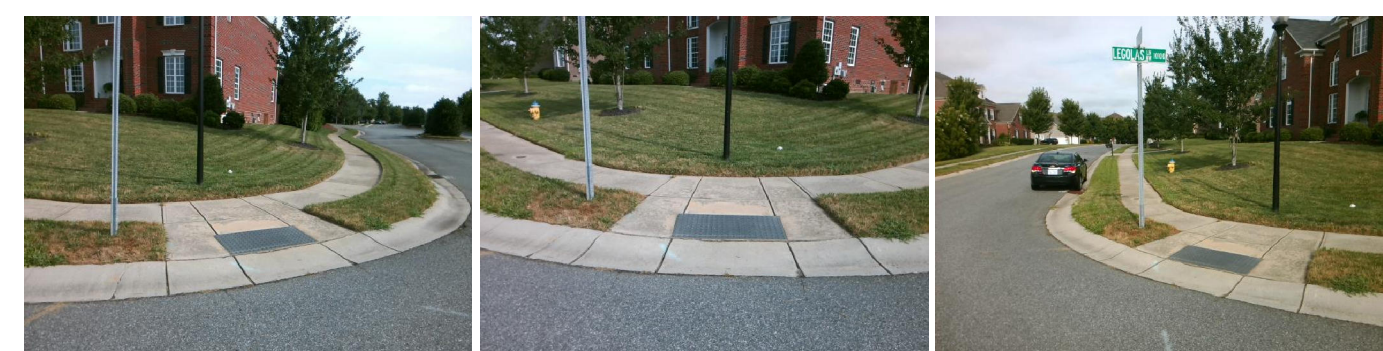
| ADA ID: A99DCC64462E | Ramp Type: PerpDiag | Initial Pass/Fail: Fail | Overall Compliance: No |

| Codes/Mitigation Info/Possible Solution | | | Field Measurements/Component Compliance | | |
|---|---|---|---|---|---|
| | | | No | Ramp Width (in) | 41.0 |
| <p>Surveyor Notes:</p> <p>N/A</p> <p>PROW/ADA:</p> <p>Not Found, R304.5.1</p> | | | N/A | Flare Type RT | N/A |

| Codes/Mitigation Info/Possible Solution | | | Field Measurements/Component Compliance | | |
|---|---|---|---|---|---|
| | Remove & Replace Curb Ramp With Two New Directional Ramps or Equivalent. | | Yes | Ramp Length (in) | 47.0 |
