# Access Compliance Report

## Public Rights-of-Way

### (Curb Ramps)

Intersection ID: 24360	Main Street: BIRNEN_DR	Cross Street: ESSEN_LN	Location: NW
ADA ID: AB594B1678C8	Ramp Type: PerpDiag	Initial Pass/Fail: Fail	Overall Compliance: No
		Severity Score: 22.5

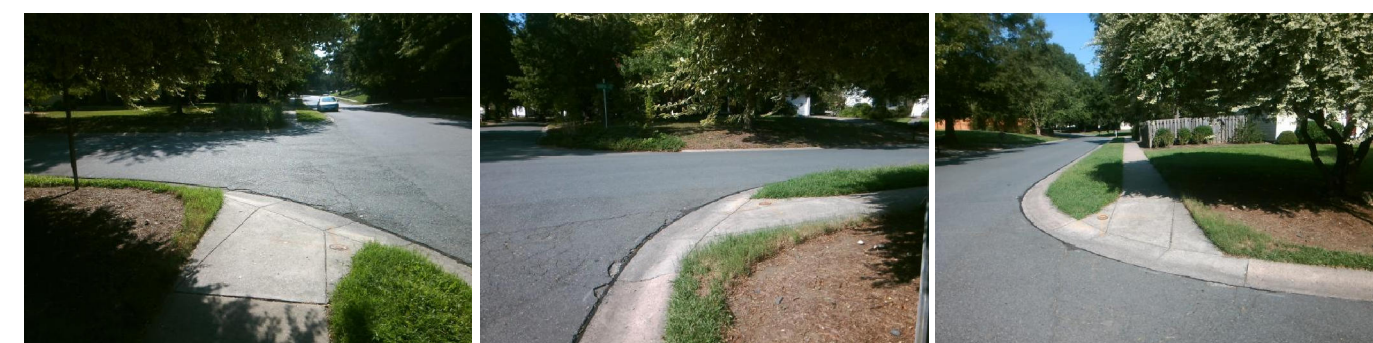
Possible Solutions:		<b>Compliance</b>	<b>Description</b>	<b>Data</b>
	<b>Remove &amp; Replace Curb Ramp With Two New Directional Ramps or Equivalent.</b>		<b>No</b>	Ramp Length (in)	77.0
			<b>No</b>	Ramp Width (in)	45.0
			<b>N/A</b>	Flare Type LT	N/A
			<b>N/A</b>	Flare Slope LT (%)	N/A
			<b>N/A</b>	Flare Traversable LT?	N/A
			<b>N/A</b>	Landing Length (in)	N/A
			<b>N/A</b>	Landing Width (in)	N/A
			<b>N/A</b>	Landing Slope (%)	N/A
			<b>N/A</b>	Landing X Slope (%)	N/A
<p>Surveyor Notes:</p> <p><b>N/A</b></p> <p>PROW/ADA:</p> <p><b>Not Found, R304.5.1, R304.2.2, R304.5.3</b></p>			<b>N/A</b>	Flare Type RT	N/A
			<b>N/A</b>	Flare Slope RT (%)	N/A
			<b>N/A</b>	Flare Traversable RT?	N/A
			<b>N/A</b>	DWS Provided?	N/A
			<b>N/A</b>	DWS Contrast?	N/A
			<b>N/A</b>	DWS Length (in)	N/A
			<b>N/A</b>	DWS Full Width?	N/A

<b>N/A</b>	DWS Offset (in)	N/A
			<b>N/A</b>	Gutter Ponding?	N/A
			<b>N/A</b>	Gutter Lip Ht (in)	N/A
<p>Total Cost:</p> <p><b>\$ 3200.00</b></p>			<b>No</b>	Painted X Walk1?	No
				X Walk 1 Direction	To SW
			<b>N/A</b>	X Walk 1 Width (in)	N/A
			<b>3.5</b>	X Walk 1 Slope (%)	
			<b>2.5</b>	X Walk 1 X Slope (%)	
			<b>N/A</b>	Ramp inside XWalk1?	N/A
			<b>0.9</b>	Road Slope (%)	N/A
			<b>4.8</b>	Road X Slope (%)	N/A
			<b>N/A</b>	Any Obstructions?	N/A
				Obstruction Type	
			<b>N/A</b>	Storm Grate/Utility Hazard?	N/A
				Storm Grate/Utility Type	
			<b>N/A</b>		N/A
			<b>Yes</b>	Surface Condition? (G/P)	Good
