Access Compliance Report

Public Rights-of-Way

| Intersection ID: 14278 | Main Street: ROMARE_BEARDEN_DR | Cross Street: FARMER_ST | Location: SE |
| ADA ID: AD12077A3A33 | Ramp Type: Perp | Initial Pass/Fail: Fail | Overall Compliance: No |

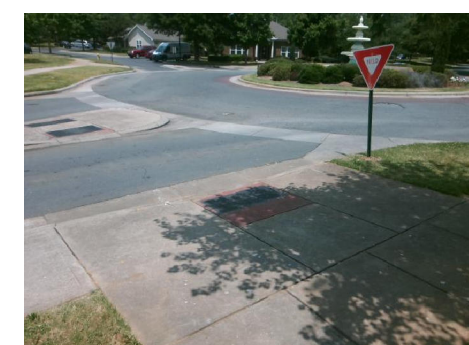
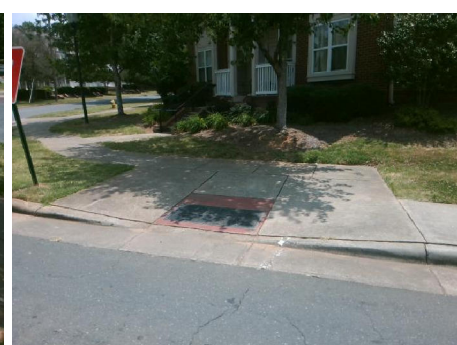
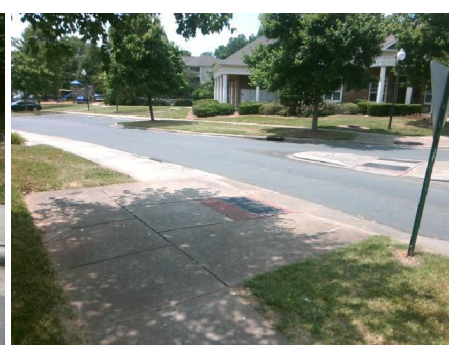
| Compliance | Description | Data | Compliance | Description | Data |
|---|---|---|---|---|---|
| Yes | Ramp Width (in) | 53.0 | No | Ramp XSlope (%) | 3.0 |

Remove & Replace Entire Ramp.
