Access Compliance Report

Public Rights-of-Way

(Curb Ramps)

Intersection ID: 44071	Main Street: NEWLANDS_CORNER_LN	Cross Street: SEDGEMOOR_LN	Location: SE
ADA ID: B05B589DDC13	Ramp Type: PerpDiag	Initial Pass/Fail: Fail	Overall Compliance: No
Severity Score: 18.75			
Codes/Mitigation Info/Possible Solution		Field Measurements/Component Compliance

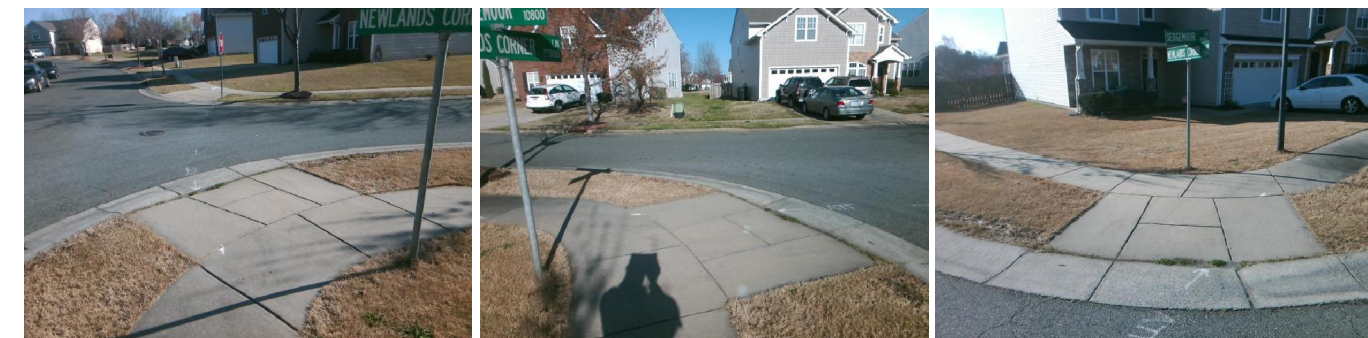
Compliance	Description	Data	Compliance	Description	Data
N/A	Ramp Length (in)	66.0	Yes	Ramp Slope (%)	5.9
No	Ramp Width (in)	35.0	No	Ramp XSlope (%)	2.3
N/A	Flare Type LT	N/A	N/A	Flare Type RT	N/A
N/A	Flare Slope LT (%)	N/A	N/A	Flare Slope RT (%)	N/A
N/A	Flare Traversable LT?	N/A	N/A	Flare Traversable RT?	N/A
N/A	Landing Length (in)	N/A	N/A	DWS Provided?	N/A
N/A	Landing Width (in)	N/A	N/A	DWS Contrast?	N/A
N/A	Landing Slope (%)	N/A	N/A	DWS Length (in)	N/A
N/A	Landing X Slope (%)	N/A	N/A	DWS Full Width?	N/A
N/A	Landing Curb? (Y/N)	N/A	N/A	DWS Offset (in)	N/A
N/A	Shared Landing?	N/A			
N/A	Gutter Ponding?	N/A	N/A	Gutter Slope (%)	N/A
N/A	Gutter Lip Ht (in)	N/A	N/A	Gutter X Slope (%)	N/A
N/A	Painted X Walk1?	No	N/A	Painted X Walk2?	No
	X Walk 1 Direction	To NE		X Walk 2 Direction	To NW
N/A	X Walk 1 Width (in)	N/A	N/A	X Walk 2 Width (in)	N/A
	X Walk 1 Slope (%)	0.8		X Walk 2 Slope (%)	5.9
	X Walk 1 X Slope (%)	4.1		X Walk 2 X Slope (%)	0.2

N/A	Ramp inside XWalk1?	N/A	N/A	Ramp inside XWalk2?	N/A
	Road Slope (%)	2.1	N/A	Clear Space?	N/A
	Road X Slope (%)	1.9	N/A	Clear Space to XWalk (in)	N/A
N/A	Any Obstructions?	N/A	N/A	Storm Grate/Utility Hazard?	N/A
	Obstruction Type			Storm Grate/Utility Type	
		N/A			N/A
		Yes		Surface Condition? (G/P)	Good

Remove & Replace Curb Ramp With Two New Directional Ramps or Equivalent.
