# Access Compliance Report

## Public Rights-of-Way

### (Curb Ramps)

Intersection ID: 51519	Main Street: E JOHN BELK RA	Cross Street: SOUTH BV	Location: SW
ADA ID: B0A54C5D5BA8	Ramp Type: Perp	Initial Pass/Fail: Fail	Overall Compliance: No
			Severity Score: 8.75

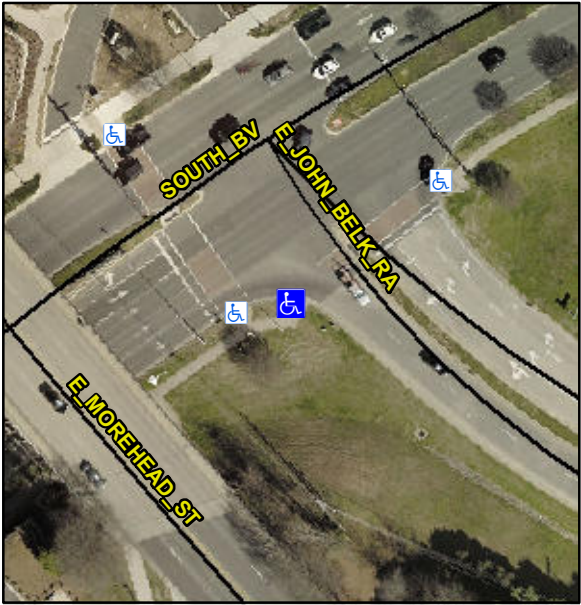
Compliance	Description	Data	Compliance	Description	Data
N/A	Ramp Length (in)	160.0	Yes	Ramp Slope (%)	5.7
No	Ramp Width (in)	47.0	Yes	Ramp XSlope (%)	0.9
N/A	Flare Type LT	N/A	N/A	Flare Type RT	N/A
N/A	Flare Slope LT (%)	N/A	N/A	Flare Slope RT (%)	N/A
N/A	Flare Traversable LT?	N/A	N/A	Flare Traversable RT?	N/A
N/A	Landing Length (in)	N/A	N/A	DWS Provided?	N/A
N/A	Landing Width (in)	N/A	N/A	DWS Contrast?	N/A
N/A	Landing Slope (%)	N/A	N/A	DWS Length (in)	N/A
N/A	Landing X Slope (%)	N/A	N/A	DWS Full Width?	N/A
N/A	Landing Curb? (Y/N)	N/A	N/A	DWS Offset (in)	N/A
N/A	Shared Landing?	N/A			
N/A	Gutter Ponding?	N/A	N/A	Gutter Slope (%)	N/A
N/A	Gutter Lip Ht (in)	N/A	N/A	Gutter X Slope (%)	N/A
N/A	Painted X Walk1?	Yes	N/A	Painted X Walk2?	N/A
	X Walk 1 Direction	To NE		X Walk 2 Direction	N/A
N/A	X Walk 1 Width (in)	133.0	N/A	X Walk 2 Width (in)	N/A
	X Walk 1 Slope (%)	4.2		X Walk 2 Slope (%)	N/A
	X Walk 1 X Slope (%)	5.9		X Walk 2 X Slope (%)	N/A

N/A	Ramp inside XWalk1?	Yes	N/A	Ramp inside XWalk2?	N/A
	Road Slope (%)	N/A	N/A	Clear Space?	N/A
	Road X Slope (%)	N/A	N/A	Clear Space to XWalk (in)	N/A
N/A	Any Obstructions?	N/A	N/A	Storm Grate/Utility Hazard?	N/A
	Obstruction Type			Storm Grate/Utility Type	
			N/A		N/A
			Yes	Surface Condition? (G/P)	Good

Possible Solutions:				
	Remove & Replace Entire Ramp.				
<p>Surveyor Notes:</p> <p>N/A</p> <p>PROW/ADA:</p> <p>R304.5.1</p>					
<p>Street 1 Name</p> <p>Stop Condition-Street 2</p> <p>Street 2 Name</p> <p>Stop Condition-Street 1</p>	E JOHN BELK RA				
	Signal				
	N/A				
	N/A				
<p>Total Cost:</p> <p>\$ 1850.00</p>
