Access Compliance Report

Public Rights-of-Way

(Curb Ramps)

Intersection ID: 11166	Main Street: EASTWOOD_DR	Cross Street: MAYWOOD_DR	Location: E
ADA ID: B1150A6819BA	Ramp Type: Perp	Initial Pass/Fail: Fail	Overall Compliance: No
Severity Score: 13.75			
Codes/Mitigation Info/Possible Solution		Field Measurements/Component Compliance

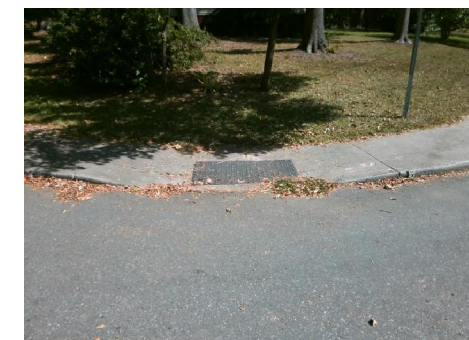
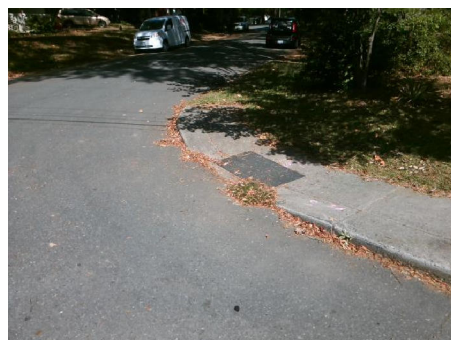
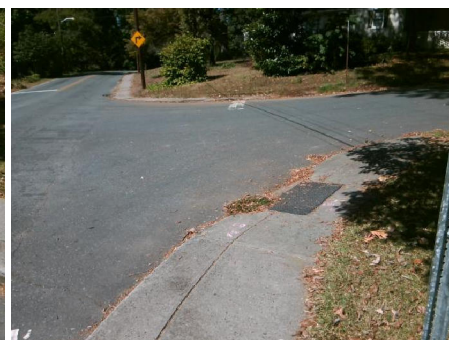
Not Found, R304.2.2, R304.5.3

Compliance	Description	Data	Compliance	Description	Data
N/A	Ramp Length (in)	46.5	No	Ramp Slope (%)	10.9
Yes	Ramp Width (in)	48.0	No	Ramp XSlope (%)	2.3
N/A	Flare Type LT	N/A	N/A	Flare Type RT	N/A
N/A	Flare Slope LT (%)	N/A	N/A	Flare Slope RT (%)	N/A
N/A	Flare Traversable LT?	N/A	N/A	Flare Traversable RT?	N/A
N/A	Landing Length (in)	N/A	N/A	DWS Provided?	N/A
N/A	Landing Width (in)	N/A	N/A	DWS Contrast?	N/A
N/A	Landing Slope (%)	N/A	N/A	DWS Length (in)	N/A
N/A	Landing X Slope (%)	N/A	N/A	DWS Full Width?	N/A
N/A	Landing Curb? (Y/N)	N/A	N/A	DWS Offset (in)	N/A
N/A	Shared Landing?	N/A			
N/A	Gutter Ponding?	N/A	N/A	Gutter Slope (%)	N/A
N/A	Gutter Lip Ht (in)	N/A	N/A	Gutter X Slope (%)	N/A
N/A	Painted X Walk1?	No	N/A	Painted X Walk2?	N/A
	X Walk 1 Direction	To NW		X Walk 2 Direction	N/A
N/A	X Walk 1 Width (in)	N/A	N/A	X Walk 2 Width (in)	N/A
	X Walk 1 Slope (%)	0.1		X Walk 2 Slope (%)	N/A
	X Walk 1 X Slope (%)	3.8		X Walk 2 X Slope (%)	N/A

N/A	Ramp inside XWalk1?	N/A	N/A	Ramp inside XWalk2?	N/A
	Road Slope (%)	N/A	N/A	Clear Space?	N/A
	Road X Slope (%)	N/A	N/A	Clear Space to XWalk (in)	N/A
N/A	Any Obstructions?	N/A	N/A	Storm Grate/Utility Hazard?	N/A
	Obstruction Type			Storm Grate/Utility Type	
		N/A			N/A
			Yes	Surface Condition? (G/P)	Good

Possible Solutions:

Remove & Replace Entire Ramp.
