Access Compliance Report

Public Rights-of-Way

(Curb Ramps)

Intersection ID: 50323	Main Street: SPRECO_LN	Cross Street: WALDON_PARK_LN	Location:	N
ADA ID: B3024C760058	Ramp Type: PerpDiag	Initial Pass/Fail: Fail	Overall Compliance: No	Severity Score: 37.5

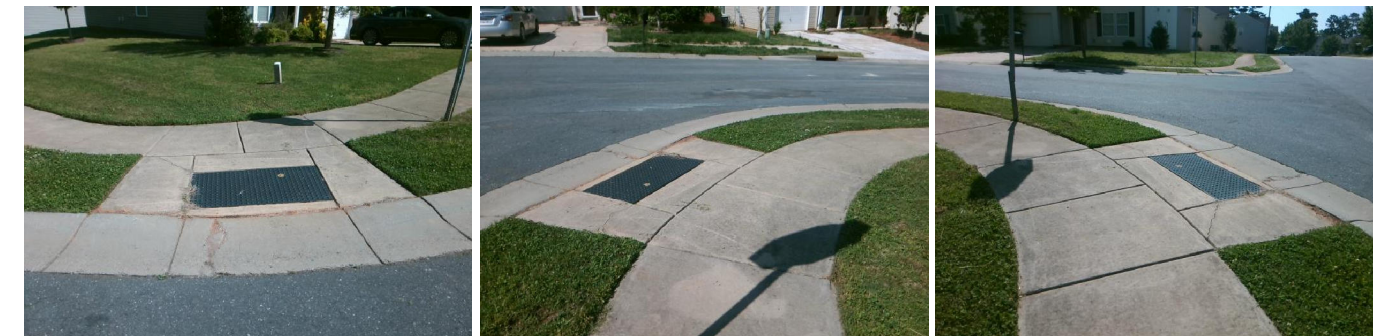
Not Found, R304.2.2, R304.5.3

Compliance	Description	Data	Compliance	Description	Data
N/A	Ramp Length (in)	47.0	No	Ramp Slope (%)	8.8
Yes	Ramp Width (in)	48.0	No	Ramp XSlope (%)	8.2
N/A	Flare Type LT	N/A	N/A	Flare Type RT	N/A
N/A	Flare Slope LT (%)	N/A	N/A	Flare Slope RT (%)	N/A
N/A	Flare Traversable LT?	N/A	N/A	Flare Traversable RT?	N/A
N/A	Landing Length (in)	N/A	N/A	DWS Provided?	N/A
N/A	Landing Width (in)	N/A	N/A	DWS Contrast?	N/A
N/A	Landing Slope (%)	N/A	N/A	DWS Length (in)	N/A
N/A	Landing X Slope (%)	N/A	N/A	DWS Full Width?	N/A
N/A	Landing Curb? (Y/N)	N/A	N/A	DWS Offset (in)	N/A
N/A	Shared Landing?	N/A			
N/A	Gutter Ponding?	N/A	N/A	Gutter Slope (%)	N/A
N/A	Gutter Lip Ht (in)	N/A	N/A	Gutter X Slope (%)	N/A
N/A	Painted X Walk1?	No	N/A	Painted X Walk2?	No
	X Walk 1 Direction	To SW		X Walk 2 Direction	To SE
N/A	X Walk 1 Width (in)	N/A	N/A	X Walk 2 Width (in)	N/A
	X Walk 1 Slope (%)	1.3		X Walk 2 Slope (%)	6.4
	X Walk 1 X Slope (%)	6.7		X Walk 2 X Slope (%)	2.9

N/A	Ramp inside XWalk1?	N/A	N/A	Ramp inside XWalk2?	N/A
	Road Slope (%)	6.6	N/A	Clear Space?	N/A
	Road X Slope (%)	3.8	N/A	Clear Space to XWalk (in)	N/A
N/A	Any Obstructions?	N/A	N/A	Storm Grate/Utility Hazard?	N/A
	Obstruction Type			Storm Grate/Utility Type	
		N/A			N/A
			Yes	Surface Condition? (G/P)	Good

Remove & Replace Curb Ramp With Two New Directional Ramps or Equivalent.
