# Access Compliance Report

## Public Rights-of-Way

| Intersection ID: 52299 | Main Street: LAKE_VISTA_LN | Cross Street: LINDA_VISTA_LN | Location: S |
| ADA ID: B3591E5C6A7E | Ramp Type: PerpDiag | Initial Pass/Fail: Fail | Overall Compliance: No |

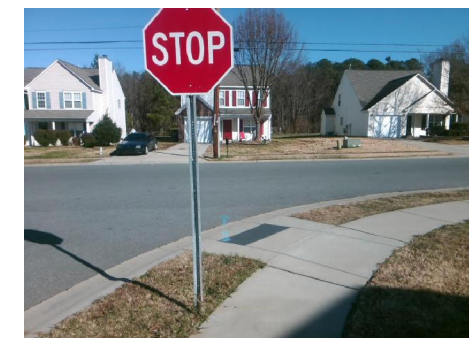
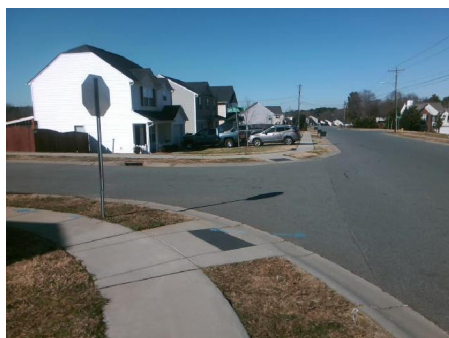
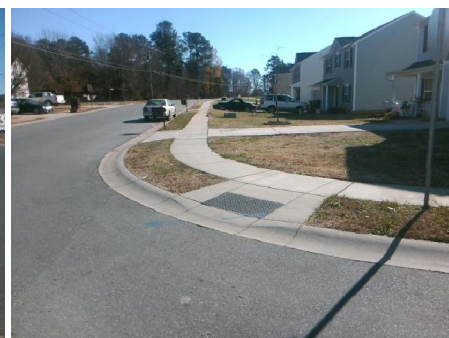
**Not Found, R304.5.1, R304.2.2**

| Compliance | Description | Data | Compliance | Description | Data |
|---|---|---|---|---|---|
| N/A | Ramp Length (in) | 48.0 | No | Ramp Slope (%) | 10.8 |
| No | Ramp Width (in) | 47.0 | Yes | Ramp XSlope (%) | 1.0 |

**Remove & Replace Curb Ramp With Two New Directional Ramps or Equivalent.**
