Access Compliance Report

Public Rights-of-Way

(Curb Ramps)

Intersection ID: 12695	Main Street: S_CALDWELL_ST	Cross Street: E TRADE ST	Location: NW
ADA ID: B36B97D2715A	Ramp Type: Combination1	Initial Pass/Fail: Fail	Overall Compliance: No
			Severity Score: 33.75

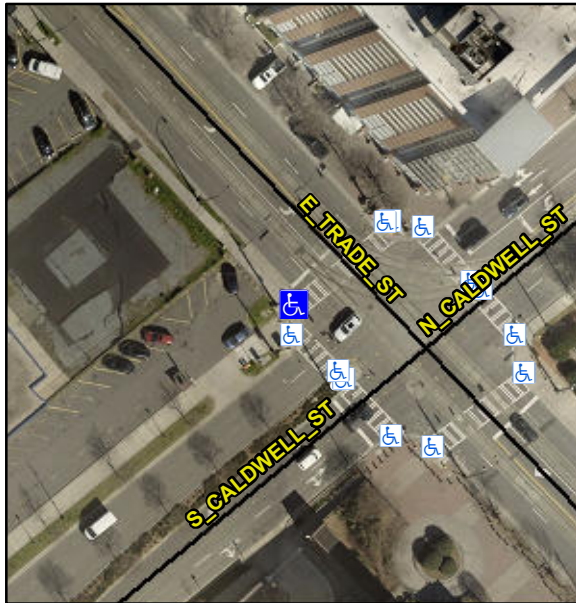
Not Found, R304.5.1, R304.5.3, R304.3.2

Compliance	Description	Data	Compliance	Description	Data
N/A	Ramp Length LT (in)	22.0	N/A	Ramp Length RT (in)	34.0
Yes	Ramp Width LT (in)	56.0	Yes	Ramp Width RT (in)	58.0
Yes	Ramp Slope LT (%)	7.3	No	Ramp Slope RT (%)	9.7
No	Ramp XSlope LT (%)	3.5	Yes	Ramp XSlope RT (%)	0.1
N/A	Ramp Length (in)	50.0	Yes	Ramp Slope (%)	5.4
No	Ramp Width (in)	47.0	No	Ramp XSlope (%)	5.4
N/A	Flare Type LT	N/A	N/A	Flare Type RT	N/A
N/A	Flare Slope LT (%)	N/A	N/A	Flare Slope RT (%)	N/A
N/A	Flare Traversable LT?	N/A	N/A	Flare Traversable RT?	N/A
N/A	Landing Length (in)	N/A	N/A	DWS Provided?	N/A
N/A	Landing Width (in)	N/A	N/A	DWS Contrast?	N/A
N/A	Landing Slope (%)	N/A	N/A	DWS Length (in)	N/A
N/A	Landing X Slope (%)	N/A	N/A	DWS Full Width?	N/A
N/A	Landing Curb? (Y/N)	N/A	N/A	DWS Offset (in)	N/A
N/A	Shared Landing?	N/A			
N/A	Gutter Ponding?	N/A	N/A	Gutter Slope (%)	N/A
N/A	Gutter Lip Ht (in)	N/A	N/A	Gutter X Slope (%)	N/A
N/A	Painted X Walk1?	Yes	N/A	Painted X Walk2?	N/A

Remove & Replace Entire Ramp.
