# Access Compliance Report

## Public Rights-of-Way

### (Curb Ramps)

| Intersection ID: 12779 | Main Street: E_TRADE_ST | Cross Street: S_DAVIDSON_ST | Location: | N |

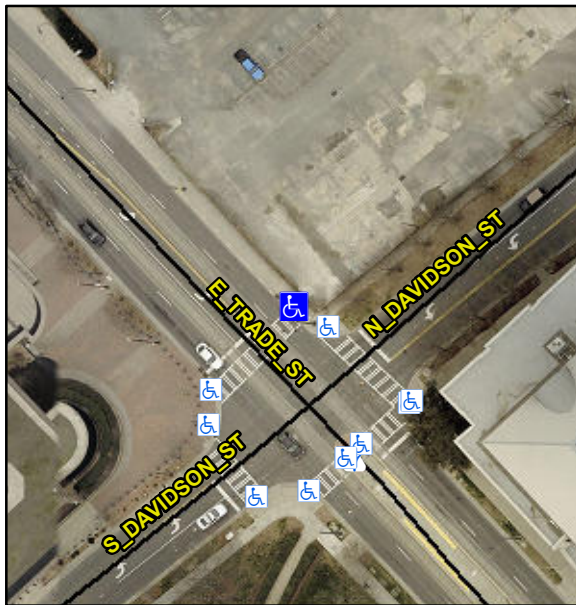
| ADA ID: B39F0FFE4D1B | Ramp Type: Combination2 | Initial Pass/Fail: Pass | Overall Compliance: No | Severity Score: 0.25 |

**Not Found, R304.5.3, R304.2.1, R304.2.2-Perp, R304.3.2-Para**

| Compliance | Description | Data | Compliance | Description | Data |
|---|---|---|---|---|---|
| No | Ramp XSlope LT (%) | 4.5 | N/A | Ramp XSlope RT (%) | N/A |
| Yes | Ramp Width (in) | 48.0 | No | Ramp XSlope (%) | 3.7 |
| No | Landing Length (in) | 54.0 | Yes | DWS Provided? | Yes |

**Remove & Replace Entire Ramp.**
