# Access Compliance Report

## Public Rights-of-Way

### (Curb Ramps)

Intersection ID: 52467	Main Street: ACQUINAS_PL	Cross Street: ST_JOHN_LN	Location: W
ADA ID: B59F58DFA1CC	Ramp Type: BlendTrans1	Initial Pass/Fail: Fail	Overall Compliance: No
Severity Score: 12.5			
Codes/Mitigation Info/Possible Solution		Field Measurements/Component Compliance

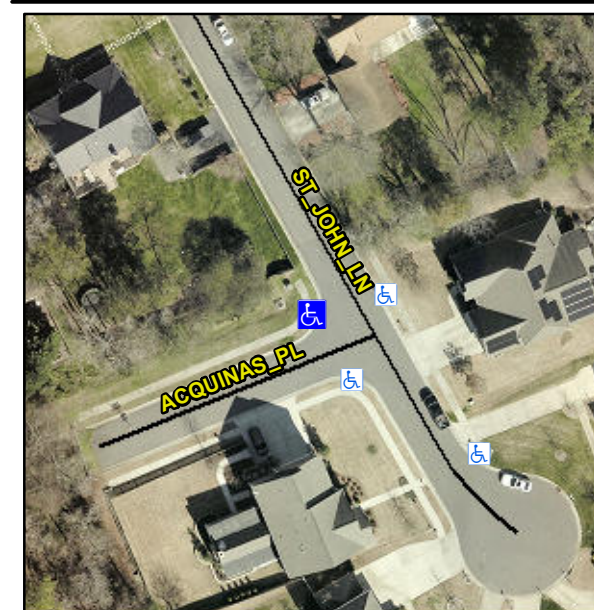
**Not Found, R304.5.3**

Compliance	Description	Data	Compliance	Description	Data
N/A	Ramp Length (in)	47.0	Yes	BlendTrans Slope (%)	3.8
Yes	Ramp Width (in)	48.0	No	BlendTrans XSlope (%)	5.2
N/A	Flare Type LT	N/A	N/A	Flare Type RT	N/A
N/A	Flare Slope LT (%)	N/A	N/A	Flare Slope RT (%)	N/A
N/A	Flare Traversable LT?	N/A	N/A	Flare Traversable RT?	N/A
N/A	Landing Length (in)	N/A	N/A	DWS Provided?	N/A
N/A	Landing Width (in)	N/A	N/A	DWS Contrast?	N/A
N/A	Landing Slope (%)	N/A	N/A	DWS Length (in)	N/A
N/A	Landing X Slope (%)	N/A	N/A	DWS Full Width?	N/A
N/A	Landing Curb? (Y/N)	N/A	N/A	DWS Offset (in)	N/A
N/A	Shared Landing?	N/A			
N/A	Gutter Ponding?	N/A	N/A	Gutter Slope (%)	N/A
N/A	Gutter Lip Ht (in)	N/A	N/A	Gutter X Slope (%)	N/A
N/A	Painted X Walk1?	No	N/A	Painted X Walk2?	No
	X Walk 1 Direction	To S		X Walk 2 Direction	To E
	X Walk 1 Width (in)	N/A		X Walk 2 Width (in)	N/A
	X Walk 1 Slope (%)	5.2		X Walk 2 Slope (%)	1.1
	X Walk 1 X Slope (%)	2.8		X Walk 2 X Slope (%)	5.2

N/A	Ramp inside XWalk1?	N/A	N/A	Ramp inside XWalk2?	N/A
	Road Slope (%)	4.7		Clear Space?	N/A
	Road X Slope (%)	1.8	N/A	Clear Space to XWalk (in)	N/A
N/A	Any Obstructions?	N/A	N/A	Storm Grate/Utility Hazard?	N/A
	Obstruction Type			Storm Grate/Utility Type	
		N/A			N/A
			Yes	Surface Condition? (G/P)	Good
			No	Curb Slope (%)	10.2

**Remove & Replace Curb Ramp With Two New Directional Ramps or Equivalent.**
