Access Compliance Report

Public Rights-of-Way

| Intersection ID: 8739 | Main Street: N_TRYON_ST | Cross Street: W_EASTWAY_DR | Location: | NW |
| ADA ID: B6C3301B5DB5 | Ramp Type: Para | Initial Pass/Fail: Fail | Overall Compliance: No | Severity Score: 25 |

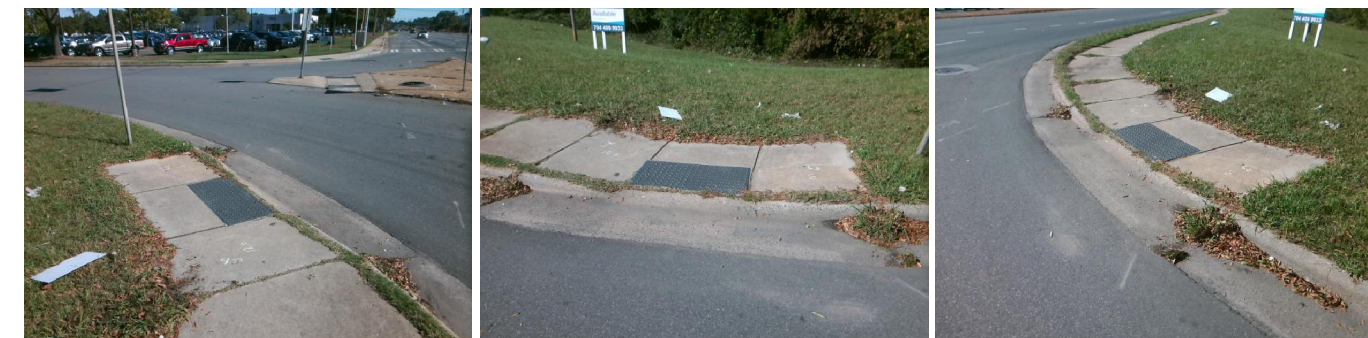
| Compliance | Description | Data | Compliance | Description | Data |
|---|---|---|---|---|---|
| No | Ramp Slope LT (%) | 12.0 | Yes | Ramp Slope RT (%) | 6.2 |

Remove & Replace Entire Ramp.
