# Access Compliance Report

## Public Rights-of-Way

### (Curb Ramps)

Intersection ID: 23869	Main Street: STERLING_LN	Cross Street: YANDLE_LN	Location: S
ADA ID: B826CED2EFC3	Ramp Type: PerpDiag	Initial Pass/Fail: Fail	Overall Compliance: No
Severity Score: 48.75			
Codes/Mitigation Info/Possible Solution		Field Measurements/Component Compliance

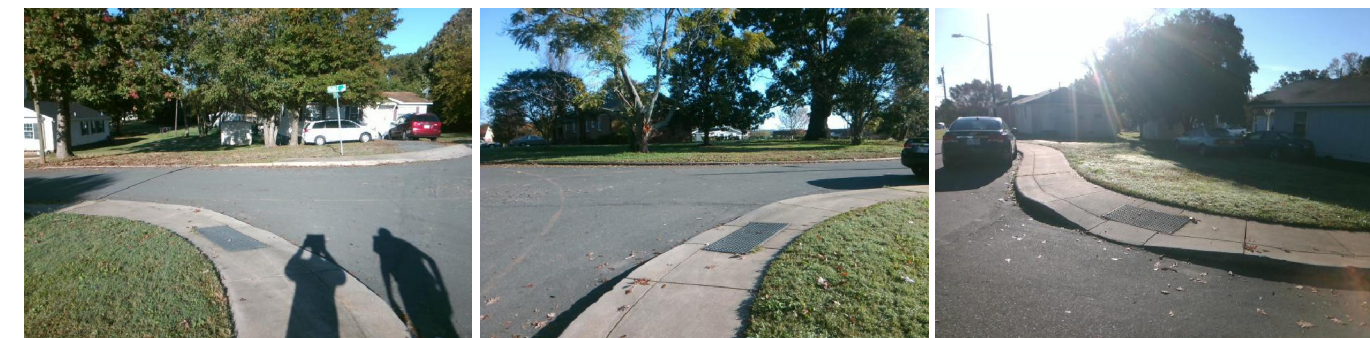
**Not Found, R304.5.1, R304.2.2, R304.5.3**

Compliance	Description	Data	Compliance	Description	Data
N/A	Ramp Length (in)	57.0	No	Ramp Slope (%)	10.4
No	Ramp Width (in)	28.0	No	Ramp XSlope (%)	4.5
N/A	Flare Type LT	N/A	N/A	Flare Type RT	N/A
N/A	Flare Slope LT (%)	N/A	N/A	Flare Slope RT (%)	N/A
N/A	Flare Traversable LT?	N/A	N/A	Flare Traversable RT?	N/A
N/A	Landing Length (in)	N/A	N/A	DWS Provided?	N/A
N/A	Landing Width (in)	N/A	N/A	DWS Contrast?	N/A
N/A	Landing Slope (%)	N/A	N/A	DWS Length (in)	N/A
N/A	Landing X Slope (%)	N/A	N/A	DWS Full Width?	N/A
N/A	Landing Curb? (Y/N)	N/A	N/A	DWS Offset (in)	N/A
N/A	Shared Landing?	N/A			
N/A	Gutter Ponding?	N/A	N/A	Gutter Slope (%)	N/A
N/A	Gutter Lip Ht (in)	N/A	N/A	Gutter X Slope (%)	N/A
N/A	Painted X Walk1?	No	N/A	Painted X Walk2?	No
	X Walk 1 Direction	To NE		X Walk 2 Direction	To NW
N/A	X Walk 1 Width (in)	N/A	N/A	X Walk 2 Width (in)	N/A
	X Walk 1 Slope (%)	5.4		X Walk 2 Slope (%)	0.4
	X Walk 1 X Slope (%)	1.8		X Walk 2 X Slope (%)	6.4

**Remove & Replace Curb Ramp With Two New Directional Ramps or Equivalent.**
