Access Compliance Report

Public Rights-of-Way

(Curb Ramps)

Intersection ID: 8895	Main Street: BINGHAM_DR	Cross Street: N_TRYON_ST	Location: SW
ADA ID: B8C3F38C4054	Ramp Type: Perp	Initial Pass/Fail: Fail	Overall Compliance: No
		Severity Score: 1.25

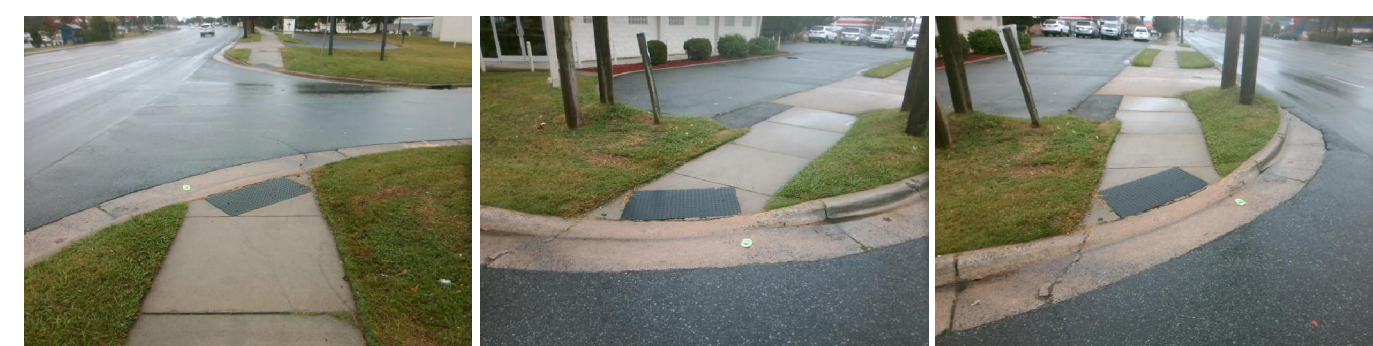
Possible Solutions:		Compliance	Description	Data
	Remove & Replace Entire Ramp.		Yes	Ramp Length (in)	25.5
			No	Ramp Width (in)	48.0
			N/A	Flare Type LT	N/A
			N/A	Flare Slope LT (%)	N/A
			N/A	Flare Traversable LT?	N/A
			N/A	Landing Length (in)	N/A
			N/A	Landing Width (in)	N/A
			N/A	Landing Slope (%)	N/A
			N/A	Landing X Slope (%)	N/A
<p>Surveyor Notes:</p> <p>N/A</p> <p>PROW/ADA:</p> <p>Not Found, R304.5.3</p>			N/A	Flare Type RT	N/A
			N/A	Flare Slope RT (%)	N/A
			N/A	Flare Traversable RT?	N/A
			N/A	DWS Provided?	N/A
			N/A	DWS Contrast?	N/A
			N/A	DWS Length (in)	N/A
			N/A	DWS Full Width?	N/A
			N/A	DWS Offset (in)	N/A
			N/A	Gutter Ponding?	N/A
			N/A	Gutter Lip Ht (in)	N/A
			No	Painted X Walk1?	N/A
				X Walk 1 Direction	To E
			N/A	X Walk 1 Width (in)	N/A
				X Walk 1 Slope (%)	2.7
				X Walk 1 X Slope (%)	4.6
			N/A	Ramp inside XWalk1?	N/A

N/A	Road Slope (%)	N/A
			N/A	Road X Slope (%)	N/A
			N/A	Any Obstructions?	N/A
				Obstruction Type	
Total Cost: \$ 1850.00			N/A	Storm Grate/Utility Hazard?	N/A
			N/A	Storm Grate/Utility Type	N/A
			Yes	Surface Condition? (G/P)	Good
