Access Compliance Report

Public Rights-of-Way

(Curb Ramps)

Intersection ID: 48942	Main Street: MITCHELL GRANT WY	Cross Street: MORGAN LEE AV	Location: SE
ADA ID: B9A96317611A	Ramp Type: Combination2	Initial Pass/Fail: Fail	Overall Compliance: No
Severity Score: 21.25			
Codes/Mitigation Info/Possible Solution		Field Measurements/Component Compliance

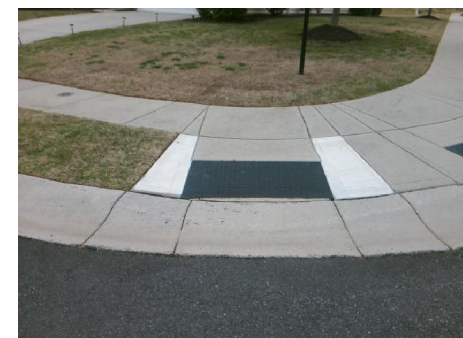
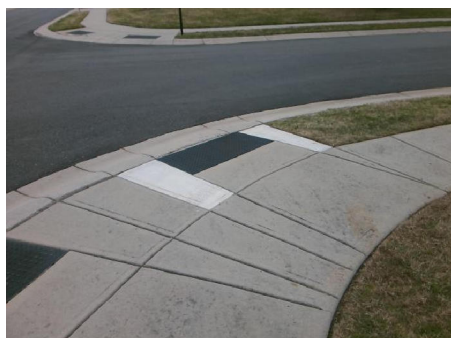
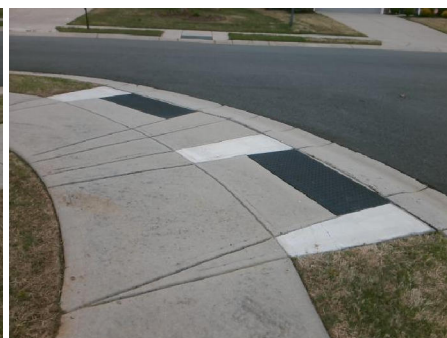
LT RP < 5%

Not Found, R304.5.1, R304.5.3

Compliance	Description	Data	Compliance	Description	Data
N/A	Ramp Length LT (in)	1.0	N/A	Ramp Length RT (in)	8.5
N/A	Ramp Width LT (in)	48.0	No	Ramp Width RT (in)	45.5
N/A	Ramp Slope LT (%)	0.4	Yes	Ramp Slope RT (%)	6.2
N/A	Ramp XSlope LT (%)	3.4	No	Ramp XSlope RT (%)	6.0
N/A	Ramp Length (in)	46.0	Yes	Ramp Slope (%)	7.1
Yes	Ramp Width (in)	48.0	No	Ramp XSlope (%)	3.8
N/A	Flare Type LT	N/A	N/A	Flare Type RT	N/A
N/A	Flare Slope LT (%)	N/A	N/A	Flare Slope RT (%)	N/A
N/A	Flare Traversable LT?	N/A	N/A	Flare Traversable RT?	N/A
N/A	Landing Length (in)	N/A	N/A	DWS Provided?	N/A
N/A	Landing Width (in)	N/A	N/A	DWS Contrast?	N/A
N/A	Landing Slope (%)	N/A	N/A	DWS Length (in)	N/A
N/A	Landing X Slope (%)	N/A	N/A	DWS Full Width?	N/A
N/A	Landing Curb? (Y/N)	N/A	N/A	DWS Offset (in)	N/A
N/A	Shared Landing?	N/A			
N/A	Gutter Ponding?	N/A	N/A	Gutter Slope (%)	N/A
N/A	Gutter Lip Ht (in)	N/A	N/A	Gutter X Slope (%)	N/A
N/A	Painted X Walk1?	No	N/A	Painted X Walk2?	N/A

Remove & Replace Entire Ramp.
