Access Compliance Report

Public Rights-of-Way

(Curb Ramps)

Intersection ID: 20998	Main Street: CEDAR_RUN_WY	Cross Street: CRESSA_CT	Location: W
ADA ID: BADC9ACCA4D7	Ramp Type: PerpDiag	Initial Pass/Fail: Fail	Overall Compliance: No
			Severity Score: 13.75

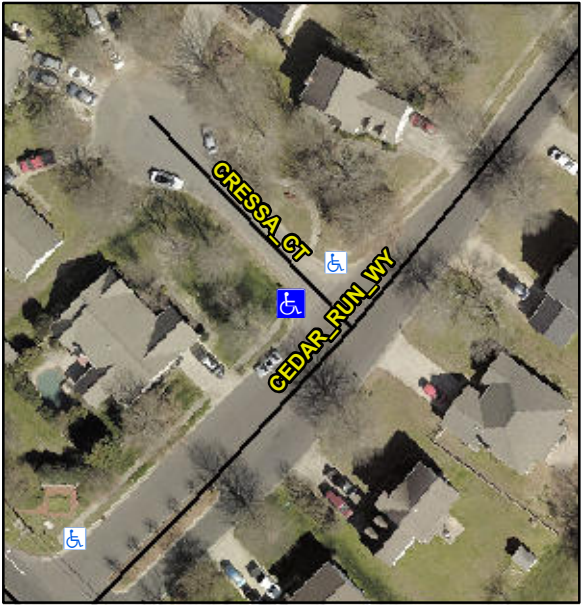
Possible Solutions:		Compliance	Description	Data
	Remove & Replace Curb Ramp With Two New Directional Ramps or Equivalent.		No	Ramp Length (in)	48.0
			Yes	Ramp Width (in)	48.0
			N/A	Flare Type LT	N/A
			N/A	Flare Slope LT (%)	N/A
			N/A	Flare Traversable LT?	N/A
			N/A	Landing Length (in)	N/A
			N/A	Landing Width (in)	N/A
			N/A	Landing Slope (%)	N/A
			N/A	Landing X Slope (%)	N/A
<p>Surveyor Notes:</p> <p>N/A</p> <p>PROW/ADA:</p> <p>Not Found, R304.2.2, R304.5.3</p>			N/A	Flare Type RT	N/A
			N/A	Flare Slope RT (%)	N/A
			N/A	Flare Traversable RT?	N/A
			N/A	DWS Provided?	N/A
			N/A	DWS Contrast?	N/A
			N/A	DWS Length (in)	N/A
			N/A	DWS Full Width?	N/A
			N/A	DWS Offset (in)	N/A
			N/A	Gutter Ponding?	N/A
			N/A	Gutter Lip Ht (in)	N/A
<p>Total Cost:</p> <p>\$ 3200.00</p>			No	Painted X Walk1?	No
			N/A	X Walk 1 Direction	To SE

N/A	X Walk 1 Width (in)	N/A
			0.2	X Walk 1 Slope (%)	0.2
			0.5	X Walk 1 X Slope (%)	2.2
			N/A	Ramp inside XWalk1?	N/A
			0.0	Road Slope (%)	N/A
			0.7	Road X Slope (%)	N/A
			N/A	Any Obstructions?	N/A
			N/A	Obstruction Type	N/A
			N/A	Clear Space?	N/A
			N/A	Clear Space to XWalk (in)	N/A
			N/A	Storm Grate/Utility Hazard?	N/A
			N/A	Storm Grate/Utility Type	N/A
			Yes	Surface Condition? (G/P)	Good
