Access Compliance Report

Public Rights-of-Way

(Curb Ramps)

Intersection ID: 13098	Main Street: S_CHURCH_ST	Cross Street: LINCOLN_ST	Location:	N
ADA ID: BB3D72BBA92F	Ramp Type: PerpDiag	Initial Pass/Fail: Fail	Overall Compliance: No	Severity Score: 25

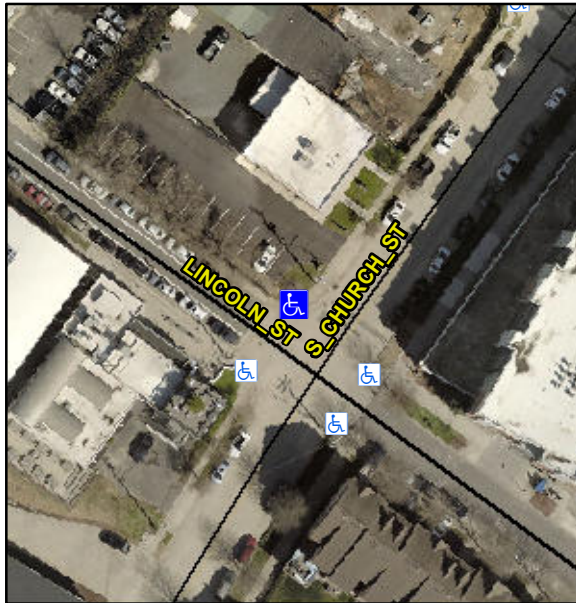
Not Found, R304.2.2, R304.5.3

Compliance	Description	Data	Compliance	Description	Data
N/A	Ramp Length (in)	78.0	No	Ramp Slope (%)	9.0
Yes	Ramp Width (in)	48.0	No	Ramp XSlope (%)	6.3
N/A	Flare Type LT	N/A	N/A	Flare Type RT	N/A
N/A	Flare Slope LT (%)	N/A	N/A	Flare Slope RT (%)	N/A
N/A	Flare Traversable LT?	N/A	N/A	Flare Traversable RT?	N/A
N/A	Landing Length (in)	N/A	N/A	DWS Provided?	N/A
N/A	Landing Width (in)	N/A	N/A	DWS Contrast?	N/A
N/A	Landing Slope (%)	N/A	N/A	DWS Length (in)	N/A
N/A	Landing X Slope (%)	N/A	N/A	DWS Full Width?	N/A
N/A	Landing Curb? (Y/N)	N/A	N/A	DWS Offset (in)	N/A
N/A	Shared Landing?	N/A			
N/A	Gutter Ponding?	N/A	N/A	Gutter Slope (%)	N/A
N/A	Gutter Lip Ht (in)	N/A	N/A	Gutter X Slope (%)	N/A
N/A	Painted X Walk1?	No	N/A	Painted X Walk2?	No
	X Walk 1 Direction	To SW		X Walk 2 Direction	To SE
N/A	X Walk 1 Width (in)	N/A	N/A	X Walk 2 Width (in)	N/A
	X Walk 1 Slope (%)	0.6		X Walk 2 Slope (%)	4.0
	X Walk 1 X Slope (%)	2.9		X Walk 2 X Slope (%)	0.2

N/A	Ramp inside XWalk1?	N/A	N/A	Ramp inside XWalk2?	N/A
	Road Slope (%)	3.0	N/A	Clear Space?	N/A
	Road X Slope (%)	3.8	N/A	Clear Space to XWalk (in)	N/A
N/A	Any Obstructions?	N/A	N/A	Storm Grate/Utility Hazard?	N/A
	Obstruction Type			Storm Grate/Utility Type	
		N/A			N/A
			Yes	Surface Condition? (G/P)	Good

Remove & Replace Curb Ramp With Two New Directional Ramps or Equivalent.
