# Access Compliance Report

## Public Rights-of-Way

### (Curb Ramps)

Intersection ID: 9305	Main Street: LUCENA_ST	Cross Street: MORETZ_AV	Location: S
ADA ID: BBDA641D6172	Ramp Type: Perp	Initial Pass/Fail: Fail	Overall Compliance: No
Severity Score: 21.25			
Codes/Mitigation Info/Possible Solution		Field Measurements/Component Compliance

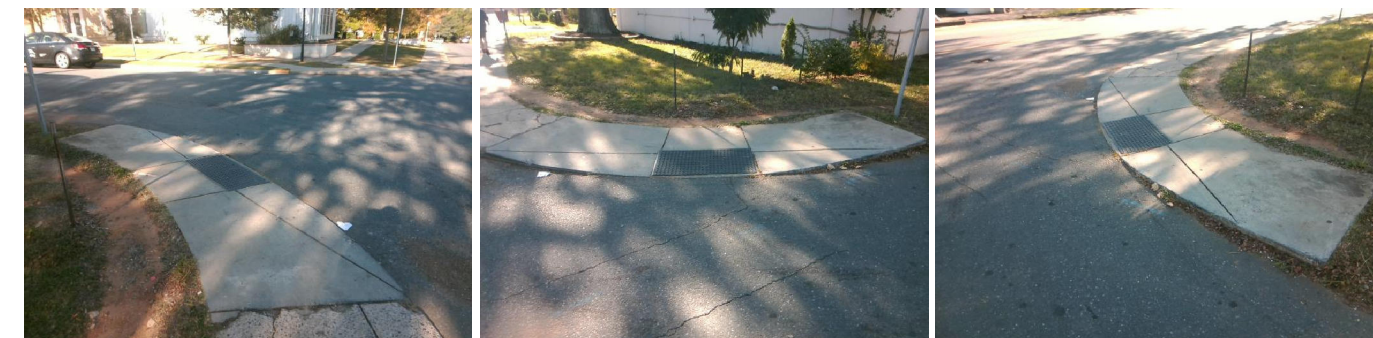
**R304.5.1, R304.5.3**

Compliance	Description	Data	Compliance	Description	Data
N/A	Ramp Length (in)	57.0	Yes	Ramp Slope (%)	7.6
No	Ramp Width (in)	38.0	No	Ramp XSlope (%)	5.3
N/A	Flare Type LT	N/A	N/A	Flare Type RT	N/A
N/A	Flare Slope LT (%)	N/A	N/A	Flare Slope RT (%)	N/A
N/A	Flare Traversable LT?	N/A	N/A	Flare Traversable RT?	N/A
N/A	Landing Length (in)	N/A	N/A	DWS Provided?	N/A
N/A	Landing Width (in)	N/A	N/A	DWS Contrast?	N/A
N/A	Landing Slope (%)	N/A	N/A	DWS Length (in)	N/A
N/A	Landing X Slope (%)	N/A	N/A	DWS Full Width?	N/A
N/A	Landing Curb? (Y/N)	N/A	N/A	DWS Offset (in)	N/A
N/A	Shared Landing?	N/A			
N/A	Gutter Ponding?	N/A	N/A	Gutter Slope (%)	N/A
N/A	Gutter Lip Ht (in)	N/A	N/A	Gutter X Slope (%)	N/A
N/A	Painted X Walk1?	No	N/A	Painted X Walk2?	N/A
	X Walk 1 Direction	To NW		X Walk 2 Direction	N/A
N/A	X Walk 1 Width (in)	N/A	N/A	X Walk 2 Width (in)	N/A
	X Walk 1 Slope (%)	0.4		X Walk 2 Slope (%)	N/A
	X Walk 1 X Slope (%)	2.7		X Walk 2 X Slope (%)	N/A

**Remove & Replace Entire Ramp.**
