Access Compliance Report

Public Rights-of-Way

(Curb Ramps)

Intersection ID: 48259	Main Street: BELMONT_RUN_LN	Cross Street: BACK_CREEK_CHURCH_RD	Location: SW
ADA ID: BDA1BE45B093	Ramp Type: Perp	Initial Pass/Fail: Pass	Overall Compliance: No
		Severity Score: 12.5

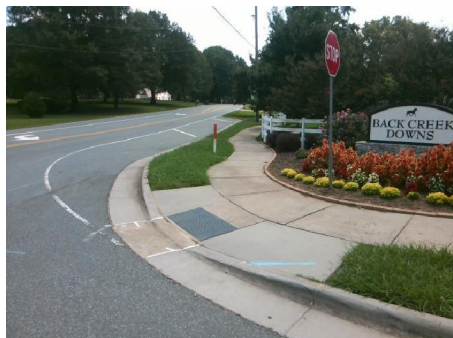
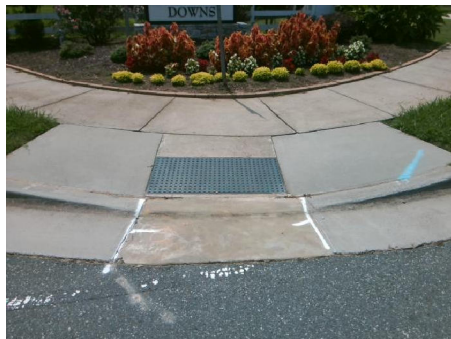
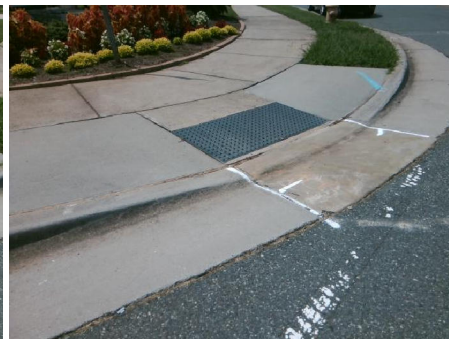
Possible Solutions:		Compliance	Description	Data	Compliance
	Remove & Replace Entire Ramp.		N/A	Ramp Length (in)	46.5	Yes
	Remove & Replace Gutter.		Yes	Ramp Width (in)	48.0	Yes
			N/A	Flare Type LT	Sloped	N/A
			N/A	Flare Slope LT (%)	6.8	N/A
			N/A	Flare Traversable LT?	No	N/A
			Yes	Landing Length (in)	60.0	Yes
			Yes	Landing Width (in)	48.0	Yes
			Yes	Landing Slope (%)	0.8	Yes
			Yes	Landing X Slope (%)	1.8	Yes
<p>Surveyor Notes:</p> <p>N/A</p> <p>PROW/ADA:</p> <p>Not Found, R305.2, R302.7.2, R304.5.4, R304.5.3</p>			N/A	Flare Type RT	N/A	N/A
			N/A	Flare Slope RT (%)	8.7	N/A
			N/A	Flare Traversable RT?	No	N/A
			Yes	DWS Provided?	Yes	Yes
			Yes	DWS Contrast?	Yes	Yes
			Yes	DWS Length (in)	24.5	Yes
			Yes	DWS Full Width?	Yes	Yes
			N/A	DWS Offset (in)	2.5	N/A
			N/A	Gutter Slope (%)	5.7	N/A
			No	Gutter X Slope (%)	2.1	N/A

<p>Total Cost: \$ 2600.00</p>			N/A	Painted X Walk1?	No	N/A
				X Walk 1 Direction	To NW	N/A
			N/A	X Walk 1 Width (in)	N/A	N/A
				X Walk 1 Slope (%)	1.0	N/A
				X Walk 1 X Slope (%)	2.4	N/A
			N/A	Ramp inside XWalk1?	N/A	N/A
			N/A	Ramp inside XWalk2?	N/A	N/A
			N/A	Clear Space?	Yes	N/A
			N/A	Clear Space to XWalk (in)	N/A	N/A
			Yes	Storm Grate/Utility Hazard?	No	Yes
<p>Obstruction Type</p>				Storm Grate/Utility Type		N/A
			N/A	Surface Condition? (G/P)	Good	Yes
