# Access Compliance Report

## Public Rights-of-Way

### (Curb Ramps)

Intersection ID: 3821	Main Street: BERSHIRE_LN	Cross Street: MARBLE_HILL_DR	Location: NW
ADA ID: BDE20092699F	Ramp Type: Perp	Initial Pass/Fail: Fail	Overall Compliance: No
Severity Score: 25			
Codes/Mitigation Info/Possible Solution		Field Measurements/Component Compliance

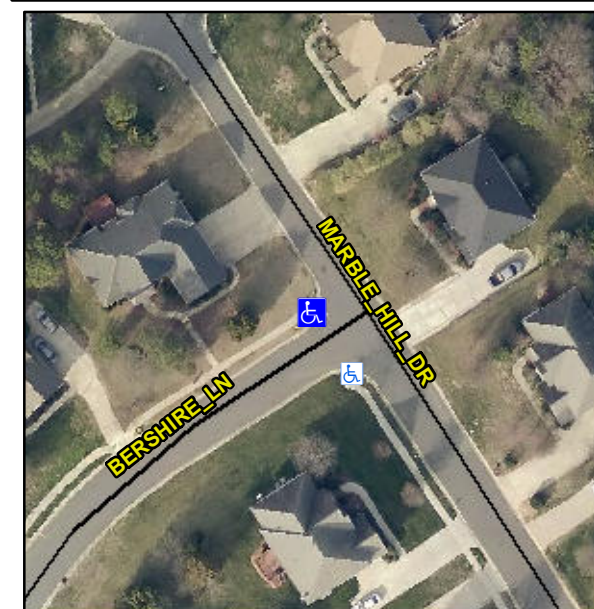
**Not Found, R304.5.3**

Compliance	Description	Data	Compliance	Description	Data
N/A	Ramp Length (in)	49.0	Yes	Ramp Slope (%)	5.6
Yes	Ramp Width (in)	69.0	No	Ramp XSlope (%)	11.1
N/A	Flare Type LT	N/A	N/A	Flare Type RT	N/A
N/A	Flare Slope LT (%)	N/A	N/A	Flare Slope RT (%)	N/A
N/A	Flare Traversable LT?	N/A	N/A	Flare Traversable RT?	N/A
N/A	Landing Length (in)	N/A	N/A	DWS Provided?	N/A
N/A	Landing Width (in)	N/A	N/A	DWS Contrast?	N/A
N/A	Landing Slope (%)	N/A	N/A	DWS Length (in)	N/A
N/A	Landing X Slope (%)	N/A	N/A	DWS Full Width?	N/A
N/A	Landing Curb? (Y/N)	N/A	N/A	DWS Offset (in)	N/A
N/A	Shared Landing?	N/A			
N/A	Gutter Ponding?	N/A	N/A	Gutter Slope (%)	N/A
N/A	Gutter Lip Ht (in)	N/A	N/A	Gutter X Slope (%)	N/A
N/A	Painted X Walk1?	No	N/A	Painted X Walk2?	N/A
	X Walk 1 Direction	To S		X Walk 2 Direction	N/A
N/A	X Walk 1 Width (in)	N/A	N/A	X Walk 2 Width (in)	N/A
	X Walk 1 Slope (%)	9.6		X Walk 2 Slope (%)	N/A
	X Walk 1 X Slope (%)	3.0		X Walk 2 X Slope (%)	N/A

N/A	Ramp inside XWalk1?	N/A	N/A	Ramp inside XWalk2?	N/A
	Road Slope (%)	N/A	N/A	Clear Space?	N/A
	Road X Slope (%)	N/A	N/A	Clear Space to XWalk (in)	N/A
N/A	Any Obstructions?	N/A	N/A	Storm Grate/Utility Hazard?	N/A
	Obstruction Type			Storm Grate/Utility Type	
		N/A			N/A
		Yes		Surface Condition? (G/P)	Good

**Remove & Replace Entire Ramp.**
