Access Compliance Report

Public Rights-of-Way

(Curb Ramps)

Intersection ID: 10780	Main Street: GESCO_ST	Cross Street: STATE_ST	Location: E
ADA ID: BE41895C1127	Ramp Type: Perp	Initial Pass/Fail: Fail	Overall Compliance: No
Severity Score: 12.5			
Codes/Mitigation Info/Possible Solution		Field Measurements/Component Compliance

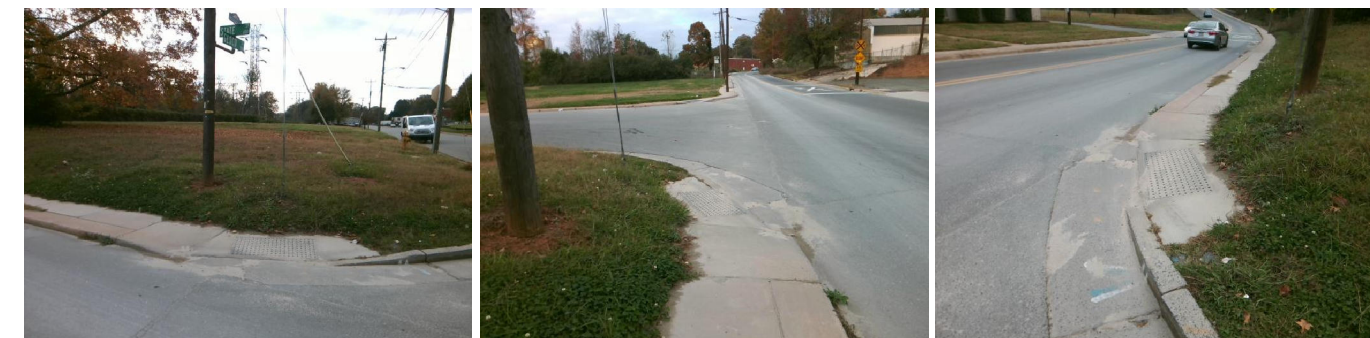
Not Found, R304.2.2

Compliance	Description	Data	Compliance	Description	Data
N/A	Ramp Length (in)	41.0	No	Ramp Slope (%)	10.6
Yes	Ramp Width (in)	80.0	Yes	Ramp XSlope (%)	1.7
N/A	Flare Type LT	N/A	N/A	Flare Type RT	N/A
N/A	Flare Slope LT (%)	N/A	N/A	Flare Slope RT (%)	N/A
N/A	Flare Traversable LT?	N/A	N/A	Flare Traversable RT?	N/A
N/A	Landing Length (in)	N/A	N/A	DWS Provided?	N/A
N/A	Landing Width (in)	N/A	N/A	DWS Contrast?	N/A
N/A	Landing Slope (%)	N/A	N/A	DWS Length (in)	N/A
N/A	Landing X Slope (%)	N/A	N/A	DWS Full Width?	N/A
N/A	Landing Curb? (Y/N)	N/A	N/A	DWS Offset (in)	N/A
N/A	Shared Landing?	N/A			
N/A	Gutter Ponding?	N/A	N/A	Gutter Slope (%)	N/A
N/A	Gutter Lip Ht (in)	N/A	N/A	Gutter X Slope (%)	N/A
N/A	Painted X Walk1?	No	N/A	Painted X Walk2?	N/A
	X Walk 1 Direction	To W		X Walk 2 Direction	N/A
N/A	X Walk 1 Width (in)	N/A	N/A	X Walk 2 Width (in)	N/A
	X Walk 1 Slope (%)	5.4		X Walk 2 Slope (%)	N/A
	X Walk 1 X Slope (%)	0.2		X Walk 2 X Slope (%)	N/A

Remove & Replace Entire Ramp.
