Access Compliance Report

Public Rights-of-Way

(Curb Ramps)

Intersection ID: 53962	Main Street: LILAC_TREE_AV	Cross Street: DENBUR_DR	Location: S
ADA ID: BE9FF8B6D256	Ramp Type: Perp	Initial Pass/Fail: Fail	Overall Compliance: No
Severity Score: 10			
Codes/Mitigation Info/Possible Solution		Field Measurements/Component Compliance

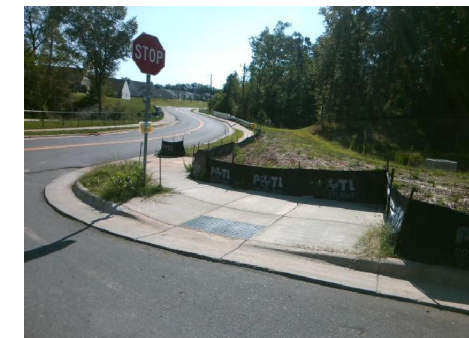
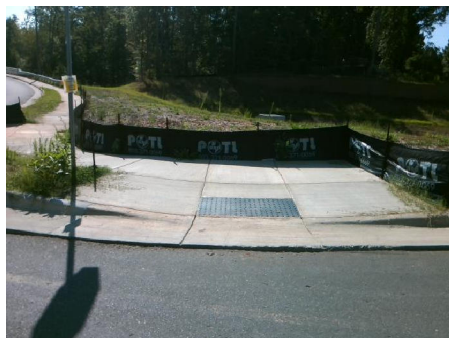
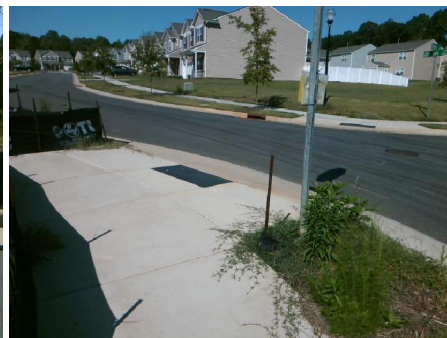
Not Found, R304.5.1, R304.5.3

Compliance	Description	Data	Compliance	Description	Data
N/A	Ramp Length (in)	48.0	Yes	Ramp Slope (%)	5.1
No	Ramp Width (in)	47.5	No	Ramp XSlope (%)	5.0
N/A	Flare Type LT	N/A	N/A	Flare Type RT	N/A
N/A	Flare Slope LT (%)	N/A	N/A	Flare Slope RT (%)	N/A
N/A	Flare Traversable LT?	N/A	N/A	Flare Traversable RT?	N/A
N/A	Landing Length (in)	N/A	N/A	DWS Provided?	N/A
N/A	Landing Width (in)	N/A	N/A	DWS Contrast?	N/A
N/A	Landing Slope (%)	N/A	N/A	DWS Length (in)	N/A
N/A	Landing X Slope (%)	N/A	N/A	DWS Full Width?	N/A
N/A	Landing Curb? (Y/N)	N/A	N/A	DWS Offset (in)	N/A
N/A	Shared Landing?	N/A			
N/A	Gutter Ponding?	N/A	N/A	Gutter Slope (%)	N/A
N/A	Gutter Lip Ht (in)	1.5	N/A	Gutter X Slope (%)	N/A
N/A	Painted X Walk1?	No	N/A	Painted X Walk2?	N/A
	X Walk 1 Direction	To NW		X Walk 2 Direction	N/A
N/A	X Walk 1 Width (in)	N/A	N/A	X Walk 2 Width (in)	N/A
	X Walk 1 Slope (%)	1.9		X Walk 2 Slope (%)	N/A
	X Walk 1 X Slope (%)	5.6		X Walk 2 X Slope (%)	N/A

N/A	Ramp inside XWalk1?	N/A	N/A	Ramp inside XWalk2?	N/A
	Road Slope (%)	N/A	N/A	Clear Space?	N/A
	Road X Slope (%)	N/A	N/A	Clear Space to XWalk (in)	N/A
N/A	Any Obstructions?	N/A	N/A	Storm Grate/Utility Hazard?	N/A
	Obstruction Type			Storm Grate/Utility Type	
		N/A			N/A
			Yes	Surface Condition? (G/P)	Good

Remove & Replace Entire Ramp.
