# Access Compliance Report

## Public Rights-of-Way

### (Curb Ramps)

Intersection ID: 26390	Main Street: BAYBROOK_LN	Cross Street: BEVINGTON_PL	Location: NW
ADA ID: BF67D9EF414C	Ramp Type: PerpDiag	Initial Pass/Fail: Fail	Overall Compliance: No
		Severity Score: 12.5

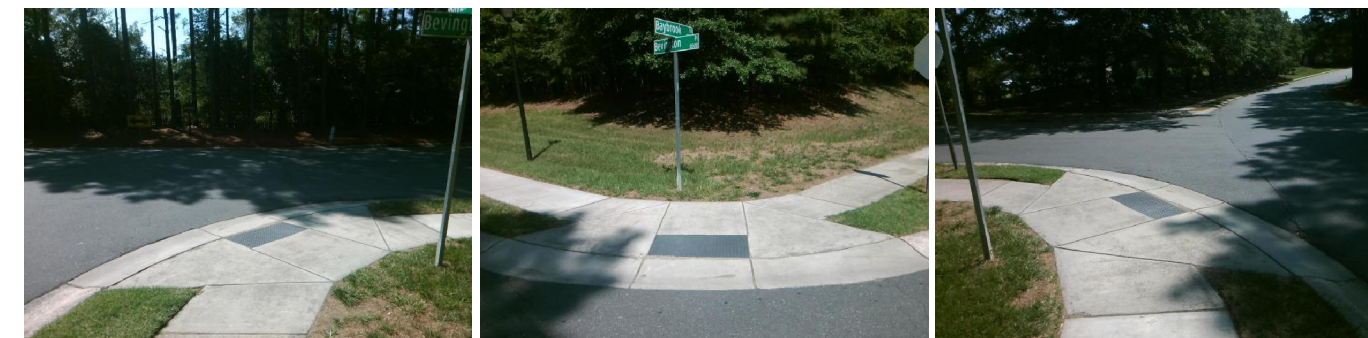
Compliance	Description	Data	Compliance	Description	Data
N/A	Ramp Length (in)	79.0	No	Ramp Slope (%)	8.6
Yes	Ramp Width (in)	48.0	Yes	Ramp XSlope (%)	0.4
N/A	Flare Type LT	N/A	N/A	Flare Type RT	N/A
N/A	Flare Slope LT (%)	N/A	N/A	Flare Slope RT (%)	N/A
N/A	Flare Traversable LT?	N/A	N/A	Flare Traversable RT?	N/A
N/A	Landing Length (in)	N/A	N/A	DWS Provided?	N/A
N/A	Landing Width (in)	N/A	N/A	DWS Contrast?	N/A
N/A	Landing Slope (%)	N/A	N/A	DWS Length (in)	N/A
N/A	Landing X Slope (%)	N/A	N/A	DWS Full Width?	N/A
N/A	Landing Curb? (Y/N)	N/A	N/A	DWS Offset (in)	N/A
N/A	Shared Landing?	N/A			
N/A	Gutter Ponding?	N/A	N/A	Gutter Slope (%)	N/A
N/A	Gutter Lip Ht (in)	N/A	N/A	Gutter X Slope (%)	N/A
N/A	Painted X Walk1?	No	N/A	Painted X Walk2?	No
	X Walk 1 Direction	To SE		X Walk 2 Direction	To NE
N/A	X Walk 1 Width (in)	N/A	N/A	X Walk 2 Width (in)	N/A
	X Walk 1 Slope (%)	3.4		X Walk 2 Slope (%)	1.5
	X Walk 1 X Slope (%)	1.6		X Walk 2 X Slope (%)	0.3

**Remove & Replace Curb Ramp With Two New Directional Ramps or Equivalent.**
