Access Compliance Report

Public Rights-of-Way

(Curb Ramps)

Intersection ID: N/A	Main Street: SCOFIELD_RD	Cross Street: WINTERCREST_LN	Location: SW
ADA ID: C27A8BA6E5C3	Ramp Type: Combination2	Initial Pass/Fail: Fail	Overall Compliance: No
			Severity Score: 13.75

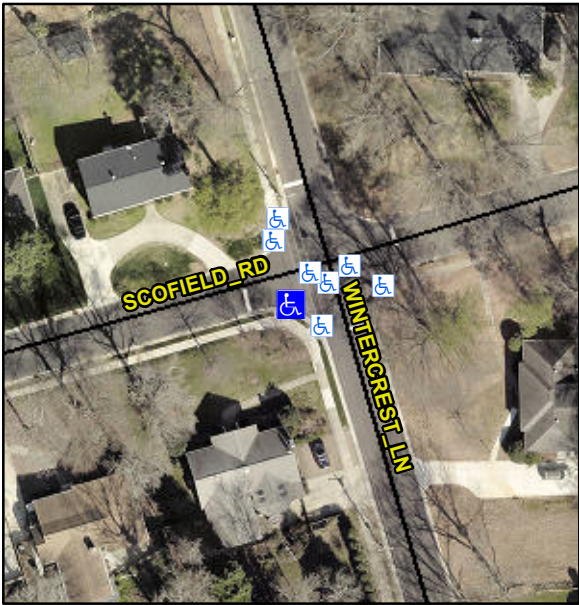
Possible Solutions:			Compliance	Description	Data	Compliance	Description	Data
	Remove & Replace Entire Ramp.			N/A	Ramp Length LT (in)	60.0	N/A	Ramp Length RT (in)	N/A
				Yes	Ramp Width LT (in)	58.0	N/A	Ramp Width RT (in)	N/A
				No	Ramp Slope LT (%)	8.7	N/A	Ramp Slope RT (%)	N/A
				Yes	Ramp XSlope LT (%)	1.1	N/A	Ramp XSlope RT (%)	N/A
				N/A	Ramp Length (in)	36.0	Yes	Ramp Slope (%)	7.2
				Yes	Ramp Width (in)	75.0	No	Ramp XSlope (%)	4.3
	Surveyor Notes:			N/A	Flare Type LT	N/A	N/A	Flare Type RT	N/A
	N/A			N/A	Flare Slope LT (%)	N/A	N/A	Flare Slope RT (%)	N/A
				N/A	Flare Traversable LT?	N/A	N/A	Flare Traversable RT?	N/A
PROW/ADA:				N/A	Landing Length (in)	N/A	N/A	DWS Provided?	N/A
Not Found, R304.5.3, R304.3.2				N/A	Landing Width (in)	N/A	N/A	DWS Contrast?	N/A
				N/A	Landing Slope (%)	N/A	N/A	DWS Length (in)	N/A
