# Access Compliance Report

## Public Rights-of-Way

### (Curb Ramps)

| Intersection ID: 48473 | Main Street: VOELTZ_DR | Cross Street: AUTUMN_OAK_DR | Location: NE |

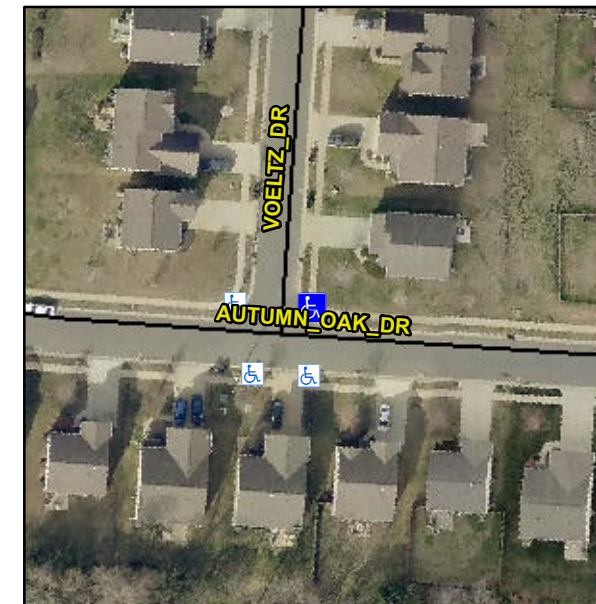
**Not Found, R304.5.1, R304.2.2, R304.5.3**

| Compliance | Description | Data | Compliance | Description | Data |
|---|---|---|---|---|---|
| N/A | Ramp Length (in) | 48.0 | No | Ramp Slope (%) | 12.2 |
| No | Ramp Width (in) | 46.0 | No | Ramp XSlope (%) | 3.1 |

**Remove & Replace Curb Ramp With Two New Directional Ramps or Equivalent.**
