Access Compliance Report

Public Rights-of-Way

(Curb Ramps)

Intersection ID: 50321	Main Street: BELMAR_PLACE_RD	Cross Street: CINDY_LN	Location: SW
ADA ID: C3B3C3777A95	Ramp Type: Directional1	Initial Pass/Fail: Fail	Overall Compliance: No
		Severity Score: 12.5

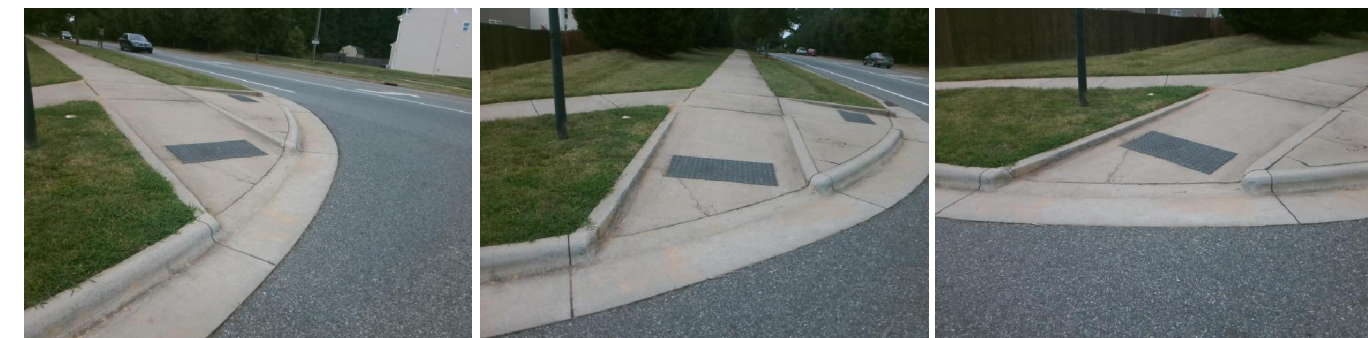
Compliance	Description	Data	Compliance	Description	Data
N/A	Ramp Length (in)	112.0	N/A	Grade Break?	N/A
Yes	Ramp Width (in)	69.5	N/A	Grade Break Slope (%)	0.0
No	Ramp Slope (%)	10.7	N/A	Grade Break XSlope (%)	0.0
Yes	Ramp XSlope (%)	1.9			
N/A	Flare Type LT	N/A	N/A	Flare Type RT	N/A
N/A	Flare Slope LT (%)	N/A	N/A	Flare Slope RT (%)	0.0
N/A	Flare Traversable LT?	N/A	N/A	Flare Traversable RT?	N/A
N/A	Landing Length (in)	0.0	N/A	DWS Provided?	N/A
N/A	Landing Width (in)	0.0	N/A	DWS Contrast?	N/A
N/A	Landing Slope (%)	0.0	N/A	DWS Length (in)	N/A
N/A	Landing X Slope (%)	0.0	N/A	DWS Full Width?	N/A
N/A	Landing Curb? (Y/N)	N/A	N/A	DWS Offset LT (in)	N/A
N/A	Shared Landing?	N/A	N/A	DWS Offset RT (in)	N/A
N/A	Gutter Ponding?	0.0	N/A	Gutter Slope (%)	N/A
N/A	Gutter Lip Ht (in)	0.0	N/A	Gutter X Slope (%)	N/A
N/A	Painted X Walk1?	No		Road Slope (%)	3.5
	X Walk 1 Direction	To E		Road X Slope (%)	6.1
	X Walk 1 Width (in)	N/A		Clear Space?	N/A

X Walk 1 Slope (%)	3.5	N/A	Clear Space to XWalk (in)	N/A
	X Walk 1 X Slope (%)	6.1	N/A	Storm Grate/Utility Hazard?	N/A
N/A	Ramp inside XWalk1?	N/A		Storm Grate/Utility Type	
N/A	Any Obstructions?	N/A			N/A
	Obstruction Type		Yes	Surface Condition? (G/P)	Good
			N/A	Curb Slope (%)	17.8

Remove & Replace Entire Ramp.
