Access Compliance Report

Public Rights-of-Way

(Curb Ramps)

Intersection ID: 12224	Main Street: MILLERTON_AV	Cross Street: FLEETWOOD_DR	Location:	N
ADA ID: C44A208714B9	Ramp Type: Perp	Initial Pass/Fail: Fail	Overall Compliance: No	Severity Score: 8.75

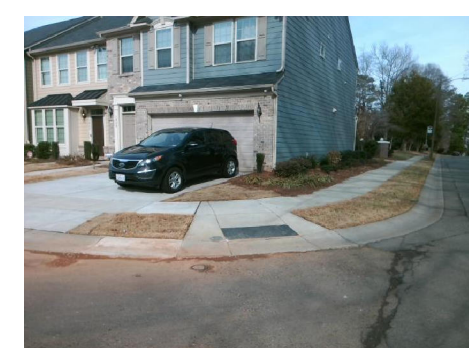
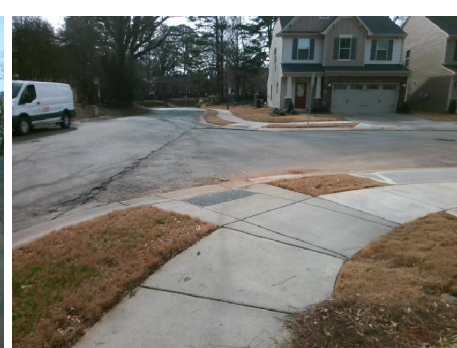
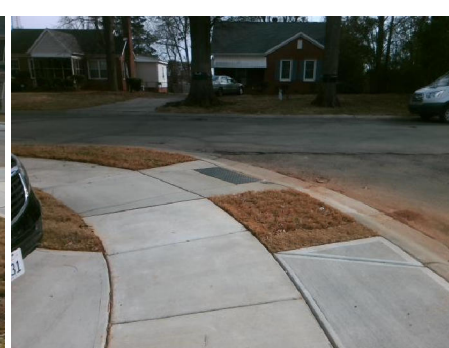
Possible Solutions:		Compliance			Description			Data					
	Remove & Replace Entire Ramp.		N/A	Ramp Length (in)		60.0		Yes	Ramp Slope (%)		8.2			
			No	Ramp Width (in)		46.5		Yes	Ramp XSlope (%)		0.6			
			N/A	Flare Type LT		N/A		N/A	Flare Type RT		N/A			
			N/A	Flare Slope LT (%)		N/A		N/A	Flare Slope RT (%)		N/A			
			N/A	Flare Traversable LT?		N/A		N/A	Flare Traversable RT?		N/A			
			N/A	Landing Length (in)		N/A		N/A	DWS Provided?		N/A			
			N/A	Landing Width (in)		N/A		N/A	DWS Contrast?		N/A			
			N/A	Landing Slope (%)		N/A		N/A	DWS Length (in)		N/A			
			N/A	Landing X Slope (%)		N/A		N/A	DWS Full Width?		N/A			
Surveyor Notes:		N/A			N/A			DWS Offset (in)			N/A			
PROW/ADA:		Not Found, R304.5.1			N/A									
					N/A			Gutter Ponding?			N/A			
					N/A			Gutter Lip Ht (in)			N/A			
					N/A			Painted X Walk1?			No

To SW			X Walk 2 Direction			N/A			
		N/A			N/A			X Walk 2 Width (in)			N/A			
					0.5			X Walk 2 Slope (%)			N/A			
					0.3			X Walk 2 X Slope (%)			N/A			
		N/A			N/A			Ramp inside XWalk2?			N/A			
					N/A			Clear Space?			N/A			
					N/A			Clear Space to XWalk (in)			N/A			
		N/A			N/A			Storm Grate/Utility Hazard?			N/A			
								Storm Grate/Utility Type						
					N/A						N/A			
								Yes			Surface Condition? (G/P)		Good
