# Access Compliance Report

## Public Rights-of-Way

### (Curb Ramps)

| Intersection ID: 48865 | Main Street: TIGRESS_CT | Cross Street: ERWIN_RD | Location: W |

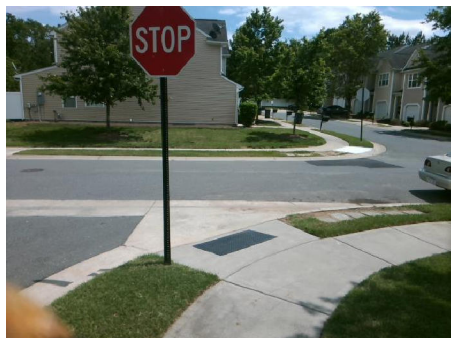
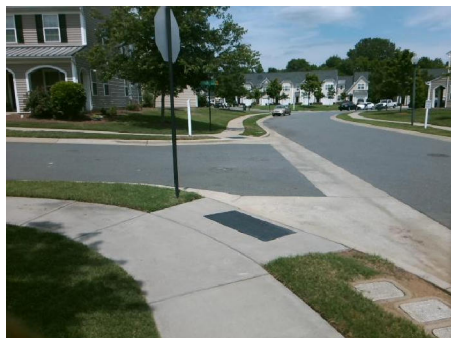
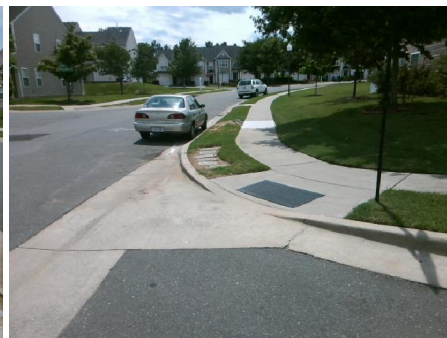
| ADA ID: C4805A6C4DA7 | Ramp Type: PerpDiag | Initial Pass/Fail: Fail | Overall Compliance: No |
| Severity Score: 13.75 | | | |

**Not Found, R304.2.2, R304.5.3**

| Compliance | Description | Data | Compliance | Description | Data |
|---|---|---|---|---|---|
| N/A | Ramp Length (in) | 48.0 | No | Ramp Slope (%) | 8.7 |
| Yes | Ramp Width (in) | 48.0 | No | Ramp XSlope (%) | 4.3 |

**Remove & Replace Curb Ramp With Two New Directional Ramps or Equivalent.**
