Access Compliance Report Public Rights-of-Way (Curb Ramps)

Intersection ID: 44610	Main Street: FIG_LN	Cross Street: PINYON_PINE_LN	Location: SE
ADA ID: C55D76DB2150	Ramp Type: Perp	Initial Pass/Fail: Pass	Overall Compliance: No Severity Score: 7.5

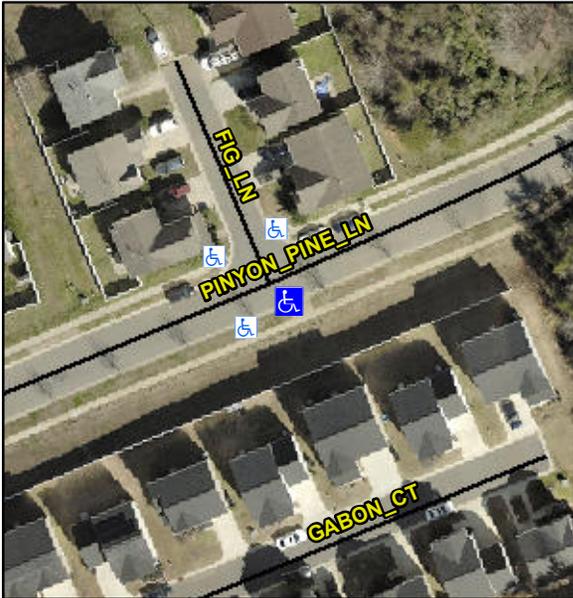
**Not Found, R304.2.1, R305.1.4,
 R305.2, R304.5.4**

Compliance	Description	Data	Compliance	Description	Data
N/A	Ramp Length (in)	84.0	Yes	Ramp Slope (%)	6.9
Yes	Ramp Width (in)	58.0	Yes	Ramp XSlope (%)	1.6
N/A	Flare Type LT	Sloped	N/A	Flare Type RT	N/A
N/A	Flare Slope LT (%)	4.6	N/A	Flare Slope RT (%)	1.2
N/A	Flare Traversable LT?	No	N/A	Flare Traversable RT?	No
No	Landing Length (in)	47.0	Yes	DWS Provided?	Yes
Yes	Landing Width (in)	58.0	Yes	DWS Contrast?	Yes
Yes	Landing Slope (%)	1.6	Yes	DWS Length (in)	25.5
Yes	Landing X Slope (%)	0.6	No	DWS Full Width?	No
N/A	Landing Curb? (Y/N)	No	No	DWS Offset (in)	2.5
N/A	Shared Landing?	Yes			
Yes	Gutter Ponding?	No	No	Gutter Slope (%)	5.1
Yes	Gutter Lip Ht (in)	0.0	Yes	Gutter X Slope (%)	1.9
N/A	Painted X Walk1?	No	N/A	Painted X Walk2?	N/A
	X Walk 1 Direction	To N		X Walk 2 Direction	N/A
N/A	X Walk 1 Width (in)	N/A	N/A	X Walk 2 Width (in)	N/A
	X Walk 1 Slope (%)	2.0		X Walk 2 Slope (%)	N/A
	X Walk 1 X Slope (%)	1.4		X Walk 2 X Slope (%)	N/A

N/A	Ramp inside XWalk1?	N/A	N/A	Ramp inside XWalk2?	N/A
	Road Slope (%)	N/A	N/A	Clear Space?	Yes
	Road X Slope (%)	N/A	N/A	Clear Space to XWalk (in)	N/A
Yes	Any Obstructions?	No	Yes	Storm Grate/Utility Hazard?	No
	Obstruction Type			Storm Grate/Utility Type	
		N/A			N/A
			Yes	Surface Condition? (G/P)	Good

Possible Solutions:
**Remove & Replace Entire Ramp.
 Remove & Replace Gutter.**
