Access Compliance Report

Public Rights-of-Way (Curb Ramps)

Intersection ID: 50710	Main Street: STEELE_CREEK_RD	Cross Street: ARRIVAL_DR	Location: NW
ADA ID: C5DDDB3389090	Ramp Type: Combination1	Initial Pass/Fail: Fail	Overall Compliance: No
			Severity Score: 21.25

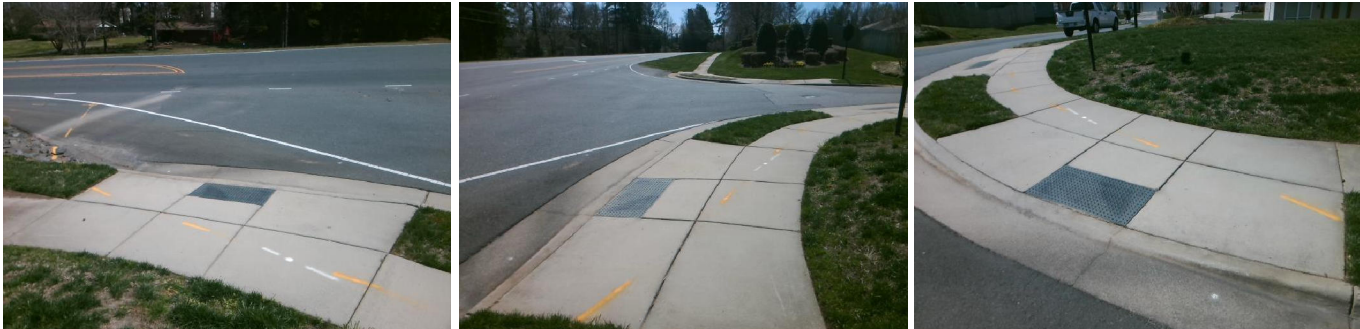
Possible Solutions:			Compliance	Description	Data	Compliance	Description	Data
	Remove & Replace Entire Ramp.			N/A	Ramp Length LT (in)	61.0	N/A	Ramp Length RT (in)	57.5
				No	Ramp Width LT (in)	44.0	No	Ramp Width RT (in)	42.5
				Yes	Ramp Slope LT (%)	8.2	Yes	Ramp Slope RT (%)	6.2
				No	Ramp XSlope LT (%)	3.3	Yes	Ramp XSlope RT (%)	1.6
				N/A	Ramp Length (in)	50.3	Yes	Ramp Slope (%)	8.3
				No	Ramp Width (in)	47.3	No	Ramp XSlope (%)	6.2
				N/A	Flare Type LT	N/A	N/A	Flare Type RT	N/A
				N/A	Flare Slope LT (%)	N/A	N/A	Flare Slope RT (%)	N/A
				N/A	Flare Traversable LT?	N/A	N/A	Flare Traversable RT?	N/A
<p>Surveyor Notes:</p> <p>N/A</p>				N/A	Landing Length (in)	N/A	N/A	DWS Provided?	N/A
				N/A	Landing Width (in)	N/A	N/A	DWS Contrast?	N/A
				N/A	Landing Slope (%)	N/A	N/A	DWS Length (in)	N/A
				N/A	Landing X Slope (%)	N/A	N/A	DWS Full Width?	N/A

N/A	Landing Curb? (Y/N)	N/A	N/A	DWS Offset (in)	N/A
				N/A	Shared Landing?	N/A			
				N/A	Gutter Ponding?	N/A	N/A	Gutter Slope (%)	N/A
				N/A	Gutter Lip Ht (in)	N/A	N/A	Gutter X Slope (%)	N/A
				N/A	Painted X Walk1?	No	N/A	Painted X Walk2?	N/A
					X Walk 1 Direction	To E		X Walk 2 Direction	N/A
<p>PROW/ADA:</p> <p>Not Found, R304.5.1, R304.5.1, R304.5.3</p>					X Walk 1 Width (in)	N/A		X Walk 2 Width (in)	N/A
					X Walk 1 Slope (%)	5.2		X Walk 2 Slope (%)	N/A
					X Walk 1 X Slope (%)	6.2		X Walk 2 X Slope (%)	N/A
				N/A	Ramp inside XWalk1?	N/A	N/A	Ramp inside XWalk2?	N/A
					Road Slope (%)	N/A		Clear Space?	N/A
					Road X Slope (%)	N/A	N/A	Clear Space to XWalk (in)	N/A
							N/A	Any Obstruction?	N/A
								Obstruction Type	N/A
							N/A	Storm Grate/Utility Hazard?	N/A

Storm Grate/Utility Type			N/A	
				Yes	Surface Condition? (G/P)	Good			Good
					Curb Slope (%)	7.7			7.7
