# Access Compliance Report

## Public Rights-of-Way

| Intersection ID: 50315 | Main Street: PORTOLA_CT | Cross Street: ESMERALDA_DR | Location: SW |
| ADA ID: C60307935721 | Ramp Type: PerpDiag | Initial Pass/Fail: Pass | Overall Compliance: No |

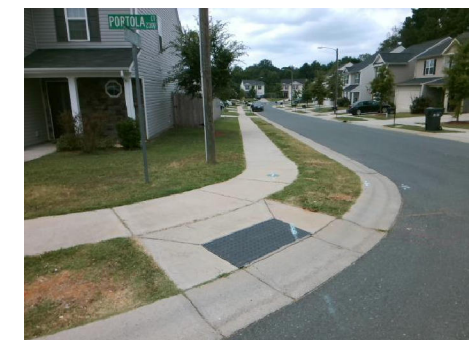
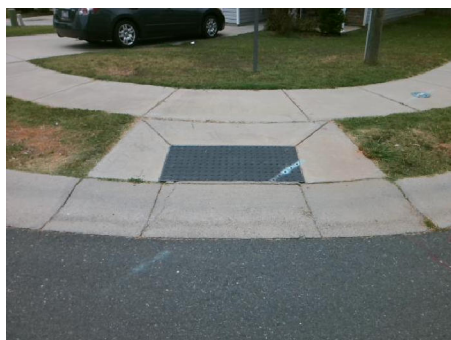
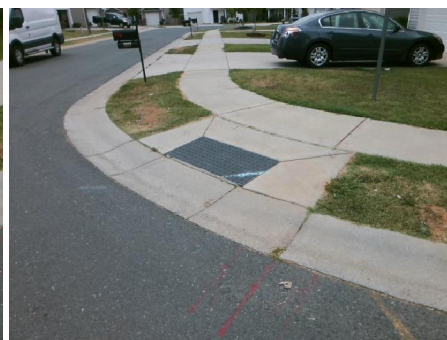
**Not Found, R304.2.1, R304.5.3, R302.7.2, R304.5.4**

| Compliance | Description | Data | Compliance | Description | Data |
|---|---|---|---|---|---|
| No | Landing Length (in) | 47.0 | Yes | DWS Provided? | Yes |
| No | Landing X Slope (%) | 3.4 | Yes | DWS Full Width? | Yes |

**Remove & Replace Curb Ramp With Two New Directional Ramps or Equivalent. Remove & Replace Gutter.**
