Access Compliance Report

Public Rights-of-Way

(Curb Ramps)

Intersection ID: 45173	Main Street: LINDEN_TREE_LN	Cross Street: MAPLEHURST_DR	Location: SW
ADA ID: C613B8A5E8A9	Ramp Type: Perp	Initial Pass/Fail: Fail	Overall Compliance: No
		Severity Score: 25

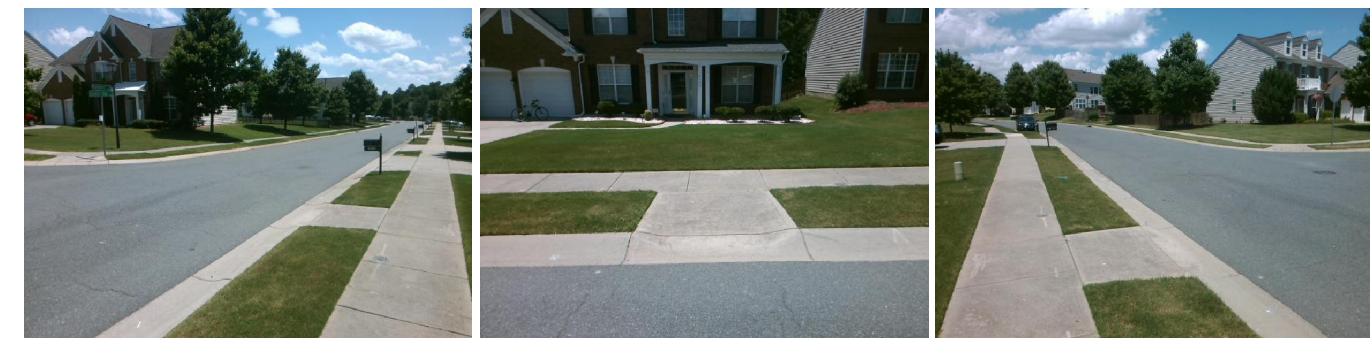
Compliance	Description	Data	Compliance	Description	Data
N/A	Ramp Length (in)	48.0	No	Ramp Slope (%)	13.7
Yes	Ramp Width (in)	48.0	Yes	Ramp XSlope (%)	1.3
N/A	Flare Type LT	N/A	N/A	Flare Type RT	N/A
N/A	Flare Slope LT (%)	N/A	N/A	Flare Slope RT (%)	N/A
N/A	Flare Traversable LT?	N/A	N/A	Flare Traversable RT?	N/A
N/A	Landing Length (in)	N/A	N/A	DWS Provided?	N/A
N/A	Landing Width (in)	N/A	N/A	DWS Contrast?	N/A
N/A	Landing Slope (%)	N/A	N/A	DWS Length (in)	N/A
N/A	Landing X Slope (%)	N/A	N/A	DWS Full Width?	N/A
N/A	Landing Curb? (Y/N)	N/A	N/A	DWS Offset (in)	N/A
N/A	Shared Landing?	N/A			
N/A	Gutter Ponding?	N/A	N/A	Gutter Slope (%)	N/A
N/A	Gutter Lip Ht (in)	N/A	N/A	Gutter X Slope (%)	N/A
N/A	Painted X Walk1?	No	N/A	Painted X Walk2?	N/A
	X Walk 1 Direction	To SE		X Walk 2 Direction	N/A
N/A	X Walk 1 Width (in)	N/A	N/A	X Walk 2 Width (in)	N/A
	X Walk 1 Slope (%)	3.3		X Walk 2 Slope (%)	N/A
	X Walk 1 X Slope (%)	2.0		X Walk 2 X Slope (%)	N/A

Remove & Replace Entire Ramp.
