Access Compliance Report

Public Rights-of-Way

(Curb Ramps)

Intersection ID: 5607	Main Street: DECATUR_CT	Cross Street: HANBERRY_BV	Location:	S
ADA ID: C64B278D2936	Ramp Type: Perp	Initial Pass/Fail: Fail	Overall Compliance: No	Severity Score: 1.25
Codes/Mitigation Info/Possible Solution		Field Measurements/Component Compliance

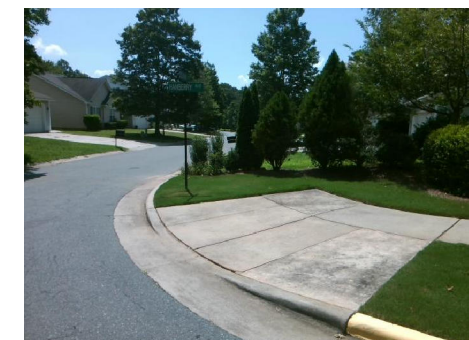
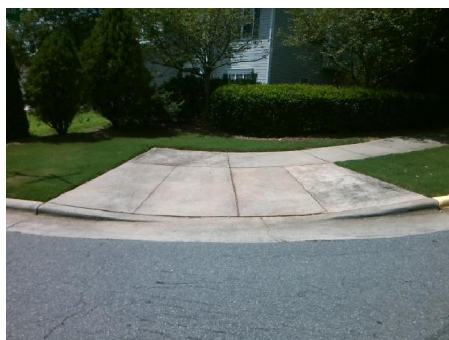
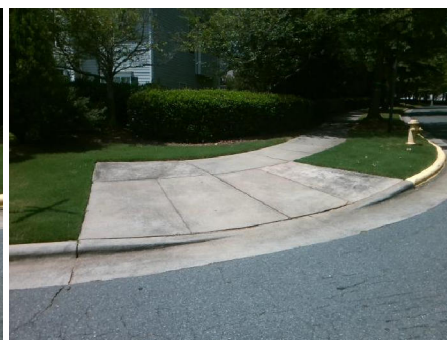
Not Found, R304.5.3

Compliance	Description	Data	Compliance	Description	Data
N/A	Ramp Length (in)	97.0	Yes	Ramp Slope (%)	7.9
Yes	Ramp Width (in)	84.0	No	Ramp XSlope (%)	4.4
N/A	Flare Type LT	N/A	N/A	Flare Type RT	N/A
N/A	Flare Slope LT (%)	N/A	N/A	Flare Slope RT (%)	N/A
N/A	Flare Traversable LT?	N/A	N/A	Flare Traversable RT?	N/A
N/A	Landing Length (in)	N/A	N/A	DWS Provided?	N/A
N/A	Landing Width (in)	N/A	N/A	DWS Contrast?	N/A
N/A	Landing Slope (%)	N/A	N/A	DWS Length (in)	N/A
N/A	Landing X Slope (%)	N/A	N/A	DWS Full Width?	N/A
N/A	Landing Curb? (Y/N)	N/A	N/A	DWS Offset (in)	N/A
N/A	Shared Landing?	N/A			
N/A	Gutter Ponding?	N/A	N/A	Gutter Slope (%)	N/A
N/A	Gutter Lip Ht (in)	N/A	N/A	Gutter X Slope (%)	N/A
N/A	Painted X Walk1?	No	N/A	Painted X Walk2?	N/A
	X Walk 1 Direction	To NE		X Walk 2 Direction	N/A
N/A	X Walk 1 Width (in)	N/A	N/A	X Walk 2 Width (in)	N/A
	X Walk 1 Slope (%)	3.8		X Walk 2 Slope (%)	N/A
	X Walk 1 X Slope (%)	3.3		X Walk 2 X Slope (%)	N/A

N/A	Ramp inside XWalk1?	N/A	N/A	Ramp inside XWalk2?	N/A
	Road Slope (%)	N/A	N/A	Clear Space?	N/A
	Road X Slope (%)	N/A	N/A	Clear Space to XWalk (in)	N/A
N/A	Any Obstructions?	N/A	N/A	Storm Grate/Utility Hazard?	N/A
	Obstruction Type			Storm Grate/Utility Type	
		N/A			N/A
			Yes	Surface Condition? (G/P)	Good

Remove & Replace Entire Ramp.
