# Access Compliance Report

## Public Rights-of-Way

### (Curb Ramps)

Intersection ID: 11921	Main Street: COUNTRY CLUB DR	Cross Street: VENTOSA DR	Location: NW
ADA ID: C672929CBA49	Ramp Type: Perp	Initial Pass/Fail: Fail	Overall Compliance: No
Severity Score: 42.5			
Codes/Mitigation Info/Possible Solution		Field Measurements/Component Compliance

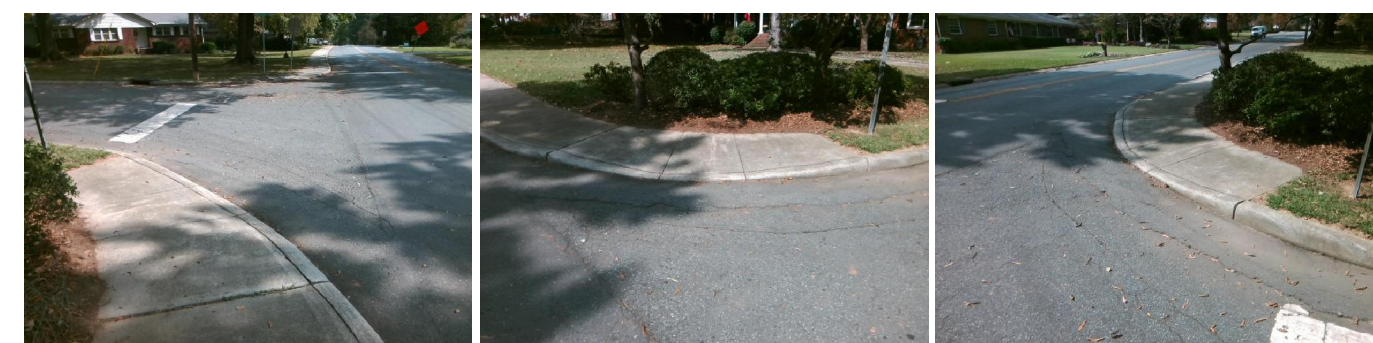
**Not Found, R304.5.1, R304.2.2**

Compliance	Description	Data	Compliance	Description	Data
N/A	Ramp Length (in)	63.0	No	Ramp Slope (%)	14.6
No	Ramp Width (in)	32.0	Yes	Ramp XSlope (%)	0.9
N/A	Flare Type LT	N/A	N/A	Flare Type RT	N/A
N/A	Flare Slope LT (%)	N/A	N/A	Flare Slope RT (%)	N/A
N/A	Flare Traversable LT?	N/A	N/A	Flare Traversable RT?	N/A
N/A	Landing Length (in)	N/A	N/A	DWS Provided?	N/A
N/A	Landing Width (in)	N/A	N/A	DWS Contrast?	N/A
N/A	Landing Slope (%)	N/A	N/A	DWS Length (in)	N/A
N/A	Landing X Slope (%)	N/A	N/A	DWS Full Width?	N/A
N/A	Landing Curb? (Y/N)	N/A	N/A	DWS Offset (in)	N/A
N/A	Shared Landing?	N/A			
N/A	Gutter Ponding?	N/A	N/A	Gutter Slope (%)	N/A
N/A	Gutter Lip Ht (in)	0.5	N/A	Gutter X Slope (%)	N/A
N/A	Painted X Walk1?	No	N/A	Painted X Walk2?	N/A
	X Walk 1 Direction	To SE		X Walk 2 Direction	N/A
N/A	X Walk 1 Width (in)	N/A	N/A	X Walk 2 Width (in)	N/A
	X Walk 1 Slope (%)	1.0		X Walk 2 Slope (%)	N/A
	X Walk 1 X Slope (%)	3.8		X Walk 2 X Slope (%)	N/A

N/A	Ramp inside XWalk1?	N/A	N/A	Ramp inside XWalk2?	N/A
	Road Slope (%)	N/A	N/A	Clear Space?	N/A
	Road X Slope (%)	N/A	N/A	Clear Space to XWalk (in)	N/A
N/A	Any Obstructions?	N/A	N/A	Storm Grate/Utility Hazard?	N/A
	Obstruction Type			Storm Grate/Utility Type	
		N/A			N/A
			Yes	Surface Condition? (G/P)	Good

**Remove & Replace Entire Ramp.**
