Access Compliance Report

Public Rights-of-Way

(Curb Ramps)

Intersection ID: 10281	Main Street: CAMPUS_ST	Cross Street: DIXON_ST	Location: NW
ADA ID: C6FC8244669F	Ramp Type: PerpDiag	Initial Pass/Fail: Fail	Overall Compliance: No
			Severity Score: 33.75

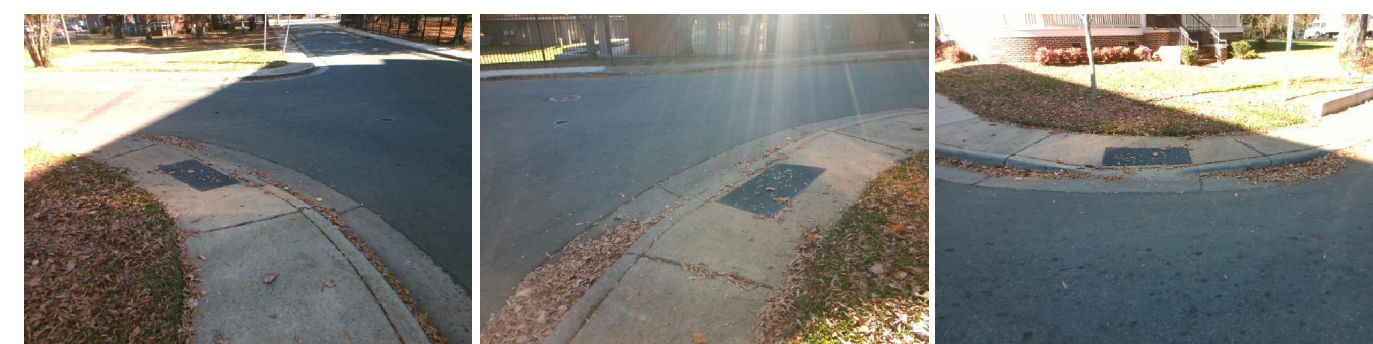
Possible Solutions:		Compliance	Description	Data
	Remove & Replace Curb Ramp With Two New Directional Ramps or Equivalent.		No	Ramp Length (in)	46.0
			No	Ramp Width (in)	44.0
			N/A	Flare Type LT	N/A
			N/A	Flare Slope LT (%)	N/A
			N/A	Flare Traversable LT?	N/A
			N/A	Landing Length (in)	N/A
			N/A	Landing Width (in)	N/A
			N/A	Landing Slope (%)	N/A
			N/A	Landing X Slope (%)	N/A
<p>Surveyor Notes:</p> <p>N/A</p> <p>PROW/ADA:</p> <p>Not Found, R304.5.1, R304.2.2, R304.5.3</p>			N/A	Flare Type RT	N/A
			N/A	Flare Slope RT (%)	N/A
			N/A	Flare Traversable RT?	N/A
			N/A	DWS Provided?	N/A
			N/A	DWS Contrast?	N/A
			N/A	DWS Length (in)	N/A
			N/A	DWS Full Width?	N/A
			N/A	DWS Offset (in)	N/A
			N/A	Gutter Ponding?	N/A
			N/A	Gutter Lip Ht (in)	N/A
<p>Total Cost:</p> <p>\$ 3200.00</p>			No	Painted X Walk2?	No
			To S	X Walk 2 Direction	To E

N/A	X Walk 2 Width (in)	N/A
			1.9	X Walk 2 Slope (%)	0.4
			3.9	X Walk 2 X Slope (%)	1.7
			N/A	Ramp inside XWalk2?	N/A
			3.1	Clear Space?	N/A
			0.5	Clear Space to XWalk (in)	N/A
			N/A	Storm Grate/Utility Hazard?	N/A
			N/A	Storm Grate/Utility Type	N/A
			N/A	Surface Condition? (G/P)	Good
