Access Compliance Report

Public Rights-of-Way

(Curb Ramps)

Intersection ID: 9087	Main Street: WESTERWOOD_DR	Cross Street: WESTERWOOD_VILLAGE_DR	Location: S
ADA ID: C71FFD51444C	Ramp Type: BlendTrans2	Initial Pass/Fail: Fail	Overall Compliance: No
		Severity Score: 25

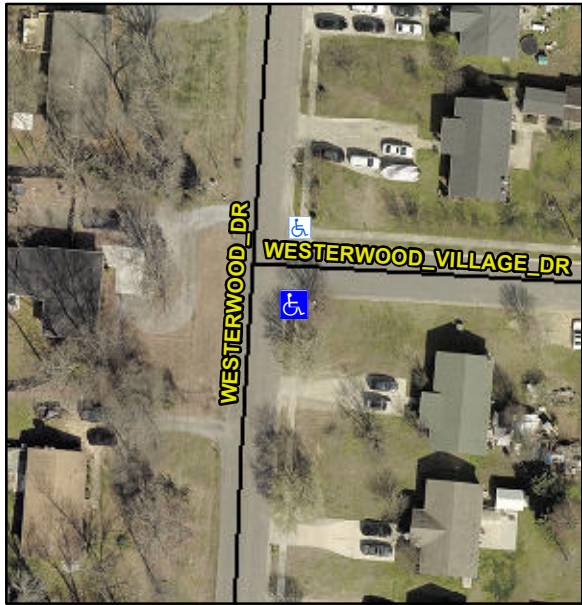
Surveyor Notes:	N/A		N/A	Landing Curb? (Y/N)	N/A	N/A	DWS Offset (in)	N/A
			N/A	Shared Landing?	N/A			
PROW/ADA:			N/A	Gutter Ponding?	N/A	N/A	Gutter Slope (%)	N/A
	R304.5.3		N/A	Gutter Lip Ht (in)	0.5	N/A	Gutter X Slope (%)	N/A
			N/A	Painted X Walk1?	No	N/A	Painted X Walk2?	N/A
				X Walk 1 Direction	To N		X Walk 2 Direction	N/A
				X Walk 1 Width (in)	N/A		X Walk 2 Width (in)	N/A
				X Walk 1 Slope (%)	0.5		X Walk 2 Slope (%)	N/A
				X Walk 1 X Slope (%)	10.1		X Walk 2 X Slope (%)	N/A
			N/A	Ramp inside XWalk1?	N/A	N/A	Ramp inside XWalk2?	N/A
				Road Slope (%)	10.1		Clear Space?	N/A
				Road X Slope (%)	0.5	N/A	Clear Space to XWalk (in)	N/A
			N/A	Any Obstructions?	N/A	N/A	Storm Grate/Utility Hazard?	N/A
				Obstruction Type			Storm Grate/Utility Type	
Total Cost:		\$ 3200.00			N/A			N/A
						Yes	Surface Condition? (G/P)	Good

Remove & Replace Curb Ramp With Two New Directional Ramps or Equivalent.
