# Access Compliance Report

## Public Rights-of-Way (Curb Ramps)

Intersection ID: 46913	Main Street: PONDEROSA_PINE_LN	Cross Street: PINYON_PINE_LN	Location:	E
ADA ID: C7571EF1ECD7	Ramp Type: PerpDiag	Initial Pass/Fail: Fail	Overall Compliance: No	Severity Score: 25
Codes/Mitigation Info/Possible Solution		Field Measurements/Component Compliance

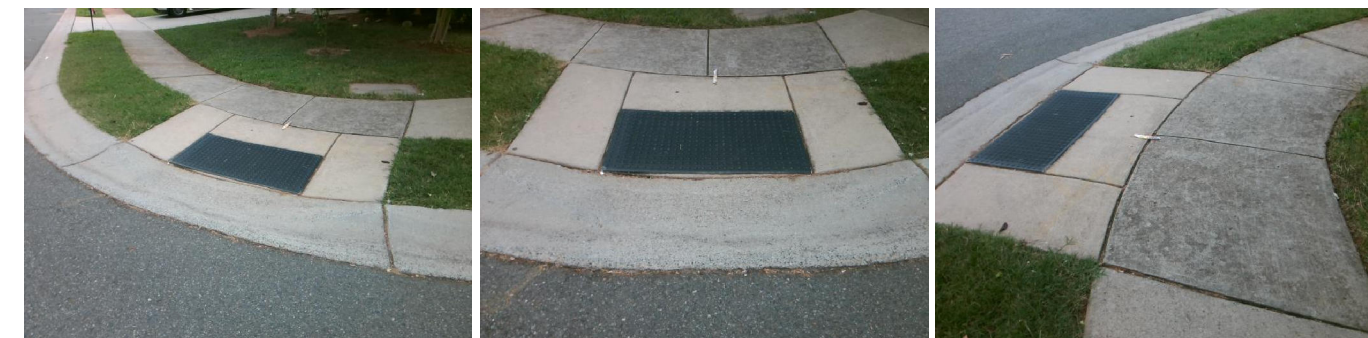
Compliance	Description	Data	Compliance	Description	Data
N/A	Ramp Length (in)	49.0	No	Ramp Slope (%)	10.3
Yes	Ramp Width (in)	48.0	No	Ramp XSlope (%)	5.6
N/A	Flare Type LT	N/A	N/A	Flare Type RT	N/A
N/A	Flare Slope LT (%)	N/A	N/A	Flare Slope RT (%)	N/A
N/A	Flare Traversable LT?	N/A	N/A	Flare Traversable RT?	N/A
N/A	Landing Length (in)	N/A	N/A	DWS Provided?	N/A
N/A	Landing Width (in)	N/A	N/A	DWS Contrast?	N/A
N/A	Landing Slope (%)	N/A	N/A	DWS Length (in)	N/A
N/A	Landing X Slope (%)	N/A	N/A	DWS Full Width?	N/A
N/A	Landing Curb? (Y/N)	N/A	N/A	DWS Offset (in)	N/A
N/A	Shared Landing?	N/A			
N/A	Gutter Ponding?	N/A	N/A	Gutter Slope (%)	N/A
N/A	Gutter Lip Ht (in)	0.5	N/A	Gutter X Slope (%)	N/A
N/A	Painted X Walk1?	No	N/A	Painted X Walk2?	No
	X Walk 1 Direction	To NW		X Walk 2 Direction	To SW
N/A	X Walk 1 Width (in)	N/A	N/A	X Walk 2 Width (in)	N/A
	X Walk 1 Slope (%)	1.9		X Walk 2 Slope (%)	4.4
	X Walk 1 X Slope (%)	2.6		X Walk 2 X Slope (%)	3.8

N/A	Ramp inside XWalk1?	N/A	N/A	Ramp inside XWalk2?	N/A
	Road Slope (%)	4.1	N/A	Clear Space?	N/A
	Road X Slope (%)	0.2	N/A	Clear Space to XWalk (in)	N/A
N/A	Any Obstructions?	N/A	N/A	Storm Grate/Utility Hazard?	N/A
	Obstruction Type			Storm Grate/Utility Type	
		N/A			N/A
			Yes	Surface Condition? (G/P)	Good

**Remove & Replace Curb Ramp With Two New Directional Ramps or Equivalent.**
