# Access Compliance Report

## Public Rights-of-Way

| Intersection ID: 28147 | Main Street: ARBOR GROVE LN | Cross Street: BENTON PL | Location: W |
| ADA ID: C78CECE2051A | Ramp Type: BlendTrans1 | Initial Pass/Fail: Fail | Overall Compliance: No |

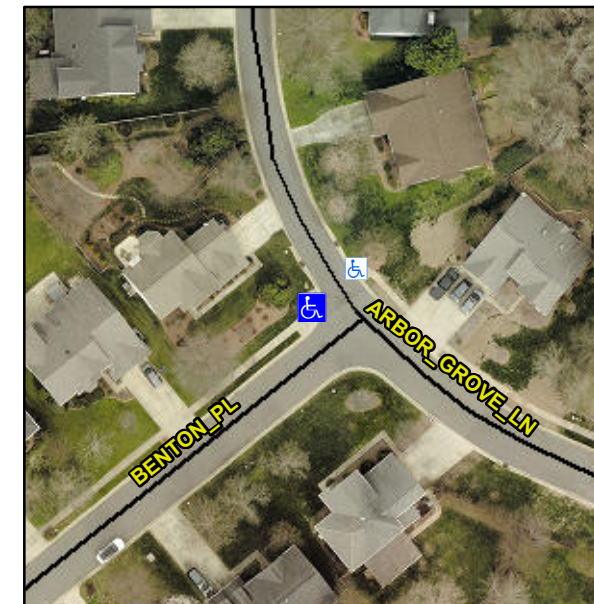
| Compliance | Description | Data | Compliance | Description | Data |
|---|---|---|---|---|---|
| Yes | Ramp Width (in) | 96.0 | No | BlendTrans XSlope (%) | 6.4 |

**Remove & Replace Curb Ramp With Two New Directional Ramps or Equivalent.**
