# Access Compliance Report

## Public Rights-of-Way

### (Curb Ramps)

| Intersection ID: 9339 | Main Street: BADGER_CT | Cross Street: WOODWARD_AV | Location: NE |

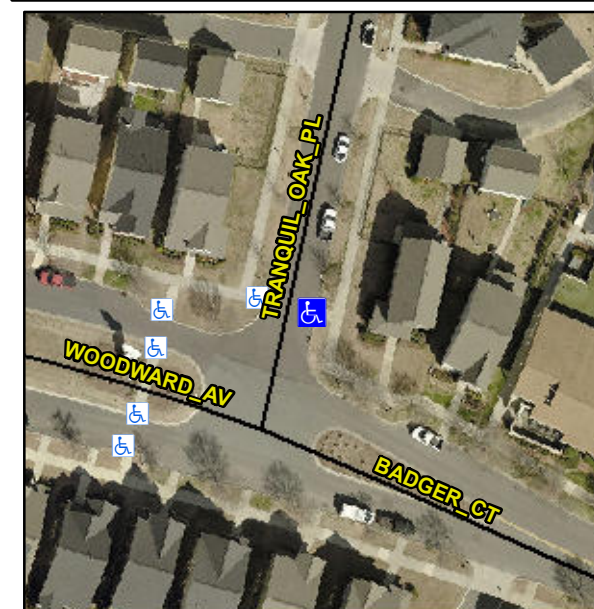
| ADA ID: C79D2D21F172 | Ramp Type: Perp | Initial Pass/Fail: Fail | Overall Compliance: No |
| Severity Score: 12.5 | | | |

**R304.2.2**

| Compliance | Description | Data | Compliance | Description | Data |
|---|---|---|---|---|---|
| N/A | Ramp Length (in) | 96.0 | No | Ramp Slope (%) | 9.3 |

**Remove & Replace Entire Ramp.**

**\$ 1850.00**
