Access Compliance Report

Public Rights-of-Way

(Curb Ramps)

Intersection ID: 14797	Main Street: LYNDHURST_AV	Cross Street: MAGNOLIA_AV	Location: S
ADA ID: C7DBDD631397	Ramp Type: PerpDiag	Initial Pass/Fail: Fail	Overall Compliance: No
Severity Score: 8.75			
Codes/Mitigation Info/Possible Solution		Field Measurements/Component Compliance

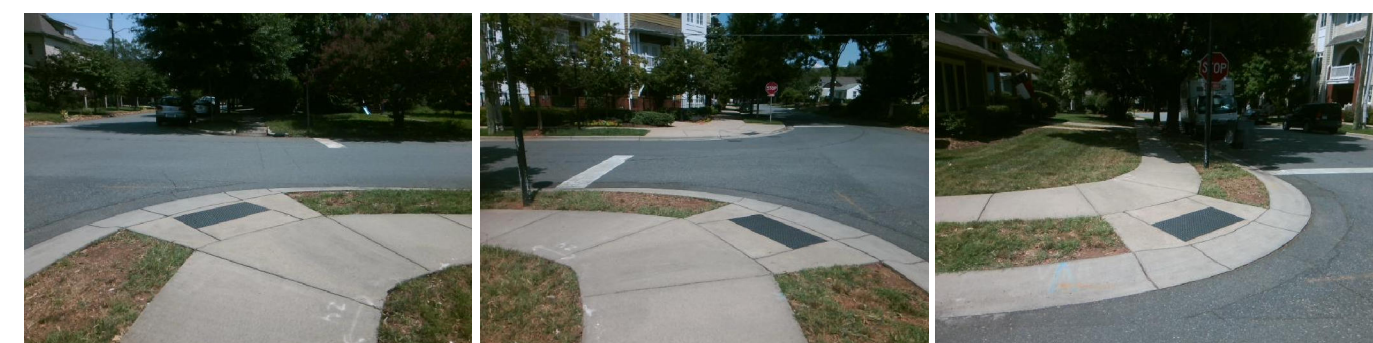
Not Found, R304.5.1

Compliance	Description	Data	Compliance	Description	Data
N/A	Ramp Length (in)	49.0	Yes	Ramp Slope (%)	5.1
No	Ramp Width (in)	47.0	Yes	Ramp XSlope (%)	1.9
N/A	Flare Type LT	N/A	N/A	Flare Type RT	N/A
N/A	Flare Slope LT (%)	N/A	N/A	Flare Slope RT (%)	N/A
N/A	Flare Traversable LT?	N/A	N/A	Flare Traversable RT?	N/A
N/A	Landing Length (in)	N/A	N/A	DWS Provided?	N/A
N/A	Landing Width (in)	N/A	N/A	DWS Contrast?	N/A
N/A	Landing Slope (%)	N/A	N/A	DWS Length (in)	N/A
N/A	Landing X Slope (%)	N/A	N/A	DWS Full Width?	N/A
N/A	Landing Curb? (Y/N)	N/A	N/A	DWS Offset (in)	N/A
N/A	Shared Landing?	N/A			
N/A	Gutter Ponding?	N/A	N/A	Gutter Slope (%)	N/A
N/A	Gutter Lip Ht (in)	N/A	N/A	Gutter X Slope (%)	N/A
N/A	Painted X Walk1?	No	N/A	Painted X Walk2?	No
	X Walk 1 Direction	To NE		X Walk 2 Direction	To NW
N/A	X Walk 1 Width (in)	N/A	N/A	X Walk 2 Width (in)	N/A
	X Walk 1 Slope (%)	1.8		X Walk 2 Slope (%)	0.2
	X Walk 1 X Slope (%)	1.4		X Walk 2 X Slope (%)	0.2

N/A	Ramp inside XWalk1?	N/A	N/A	Ramp inside XWalk2?	N/A
	Road Slope (%)	2.7	N/A	Clear Space?	N/A
	Road X Slope (%)	1.3	N/A	Clear Space to XWalk (in)	N/A
N/A	Any Obstructions?	N/A	N/A	Storm Grate/Utility Hazard?	N/A
	Obstruction Type			Storm Grate/Utility Type	
		N/A			N/A
			Yes	Surface Condition? (G/P)	Good

Remove & Replace Curb Ramp With Two New Directional Ramps or Equivalent.
