# Access Compliance Report

## Public Rights-of-Way

| Intersection ID: 24329 | Main Street: GARBOW_CT | Cross Street: MIROW_PL | Location: W |
| ADA ID: CA2B800DFBD0 | Ramp Type: Perp | Initial Pass/Fail: Fail | Overall Compliance: No |

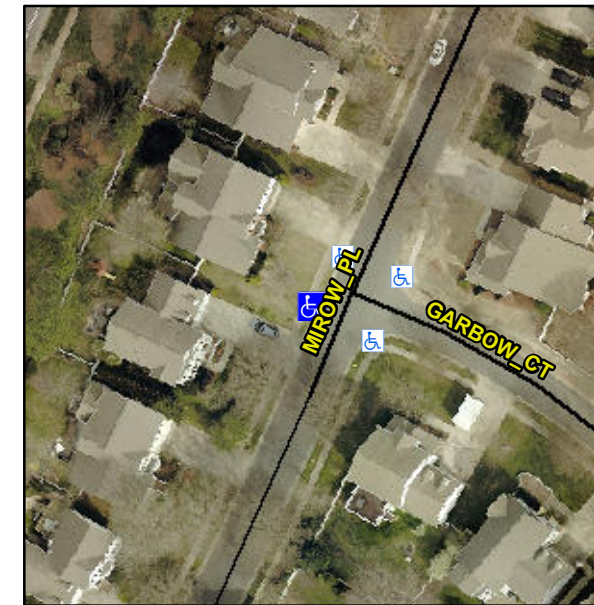
| Severity Score: 13.75 | | | |

**Not Found, R304.2.2, R304.5.3**

| Compliance | Description | Data | Compliance | Description | Data |
|---|---|---|---|---|---|
| N/A | Ramp Length (in) | 48.0 | No | Ramp Slope (%) | 10.1 |
| Yes | Ramp Width (in) | 48.0 | No | Ramp XSlope (%) | 2.6 |

**Remove & Replace Entire Ramp.**
