Access Compliance Report

Public Rights-of-Way

(Curb Ramps)

Intersection ID: 4571	Main Street: LINDEN_BERRY_LN	Cross Street: STREAM_RIDGE_DR	Location: S
ADA ID: CA54179972C0	Ramp Type: Perp	Initial Pass/Fail: Fail	Overall Compliance: No
Severity Score: 13.75			
Codes/Mitigation Info/Possible Solution		Field Measurements/Component Compliance

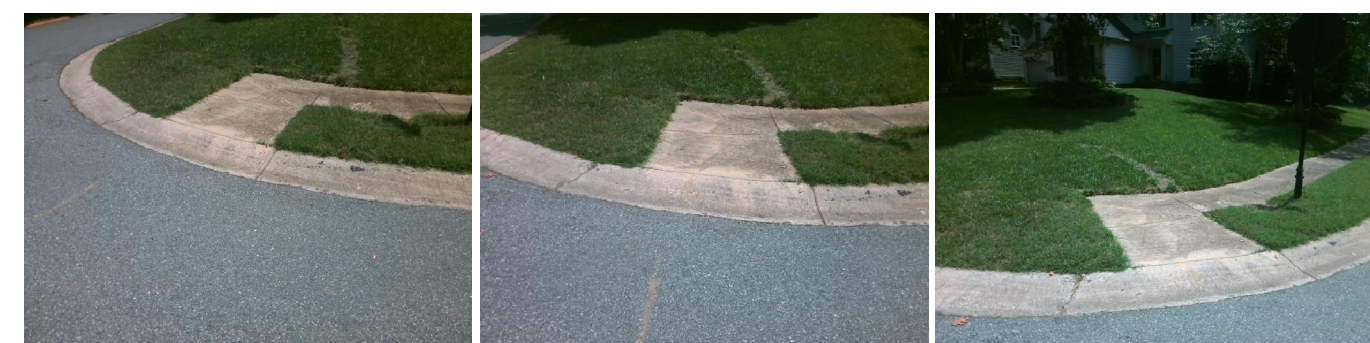
Not Found, R304.2.2, R304.5.3

Compliance	Description	Data	Compliance	Description	Data
N/A	Ramp Length (in)	42.0	No	Ramp Slope (%)	11.8
Yes	Ramp Width (in)	59.5	No	Ramp XSlope (%)	4.0
N/A	Flare Type LT	N/A	N/A	Flare Type RT	N/A
N/A	Flare Slope LT (%)	N/A	N/A	Flare Slope RT (%)	N/A
N/A	Flare Traversable LT?	N/A	N/A	Flare Traversable RT?	N/A
N/A	Landing Length (in)	N/A	N/A	DWS Provided?	N/A
N/A	Landing Width (in)	N/A	N/A	DWS Contrast?	N/A
N/A	Landing Slope (%)	N/A	N/A	DWS Length (in)	N/A
N/A	Landing X Slope (%)	N/A	N/A	DWS Full Width?	N/A
N/A	Landing Curb? (Y/N)	N/A	N/A	DWS Offset (in)	N/A
N/A	Shared Landing?	N/A			
N/A	Gutter Ponding?	N/A	N/A	Gutter Slope (%)	N/A
N/A	Gutter Lip Ht (in)	N/A	N/A	Gutter X Slope (%)	N/A
N/A	Painted X Walk1?	No	N/A	Painted X Walk2?	N/A
	X Walk 1 Direction	To NW		X Walk 2 Direction	N/A
N/A	X Walk 1 Width (in)	N/A	N/A	X Walk 2 Width (in)	N/A
	X Walk 1 Slope (%)	2.3		X Walk 2 Slope (%)	N/A
	X Walk 1 X Slope (%)	5.1		X Walk 2 X Slope (%)	N/A

N/A	Ramp inside XWalk1?	N/A	N/A	Ramp inside XWalk2?	N/A
	Road Slope (%)	N/A	N/A	Clear Space?	N/A
	Road X Slope (%)	N/A	N/A	Clear Space to XWalk (in)	N/A
N/A	Any Obstructions?	N/A	N/A	Storm Grate/Utility Hazard?	N/A
	Obstruction Type			Storm Grate/Utility Type	
		N/A			N/A
			Yes	Surface Condition? (G/P)	Good

Remove & Replace Entire Ramp.
