# Access Compliance Report

## Public Rights-of-Way

### (Curb Ramps)

Intersection ID: 8697	Main Street: HOLLAND_AV	Cross Street: ISENHOUR_ST	Location: NE
ADA ID: CA6FECDE2C2B	Ramp Type: PerpDiag	Initial Pass/Fail: Fail	Overall Compliance: No
		Severity Score: 42.5

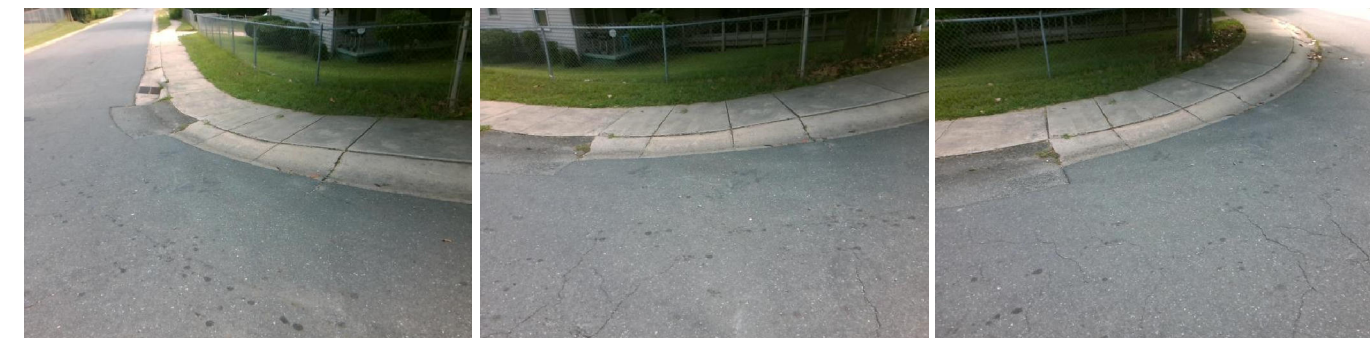
**Not Found, R304.5.1, R304.5.3**

Compliance	Description	Data	Compliance	Description	Data
N/A	Ramp Length (in)	47.0	Yes	Ramp Slope (%)	6.5
No	Ramp Width (in)	32.0	No	Ramp XSlope (%)	9.7
N/A	Flare Type LT	N/A	N/A	Flare Type RT	N/A
N/A	Flare Slope LT (%)	N/A	N/A	Flare Slope RT (%)	N/A
N/A	Flare Traversable LT?	N/A	N/A	Flare Traversable RT?	N/A
N/A	Landing Length (in)	N/A	N/A	DWS Provided?	N/A
N/A	Landing Width (in)	N/A	N/A	DWS Contrast?	N/A
N/A	Landing Slope (%)	N/A	N/A	DWS Length (in)	N/A
N/A	Landing X Slope (%)	N/A	N/A	DWS Full Width?	N/A
N/A	Landing Curb? (Y/N)	N/A	N/A	DWS Offset (in)	N/A
N/A	Shared Landing?	N/A			
N/A	Gutter Ponding?	N/A	N/A	Gutter Slope (%)	N/A
N/A	Gutter Lip Ht (in)	N/A	N/A	Gutter X Slope (%)	N/A
N/A	Painted X Walk1?	No	N/A	Painted X Walk2?	No
	X Walk 1 Direction	To W		X Walk 2 Direction	To S
N/A	X Walk 1 Width (in)	N/A	N/A	X Walk 2 Width (in)	N/A
	X Walk 1 Slope (%)	3.7		X Walk 2 Slope (%)	5.9
	X Walk 1 X Slope (%)	7.9		X Walk 2 X Slope (%)	0.4

N/A	Ramp inside XWalk1?	N/A	N/A	Ramp inside XWalk2?	N/A
	Road Slope (%)	6.4	N/A	Clear Space?	N/A
	Road X Slope (%)	3.7	N/A	Clear Space to XWalk (in)	N/A
N/A	Any Obstructions?	N/A	N/A	Storm Grate/Utility Hazard?	N/A
	Obstruction Type			Storm Grate/Utility Type	
		N/A			N/A
			Yes	Surface Condition? (G/P)	Good

**Remove & Replace Curb Ramp With Two New Directional Ramps or Equivalent.**
