| Intersection ID: 27929 | Main Street: GLENN_ABBEY_WY | Cross Street: PROVIDENCE_COUNTRY_CLUB_DR | Location: | NE |
| ADA ID: CAB53B179146 | Ramp Type: Perp | Initial Pass/Fail: Fail | Overall Compliance: No | Severity Score: 1.25 |

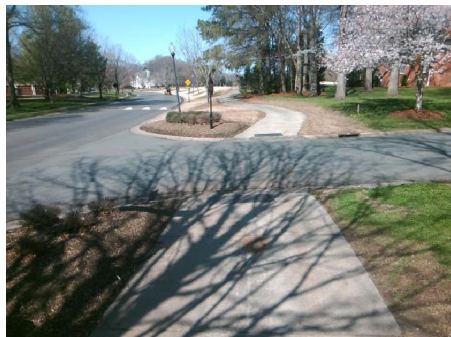
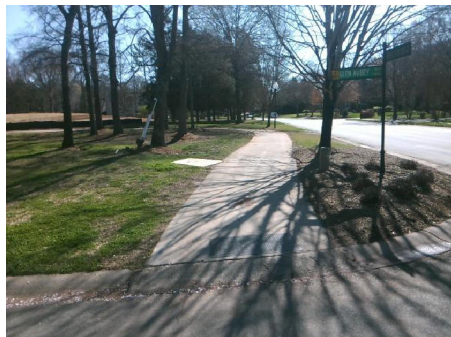
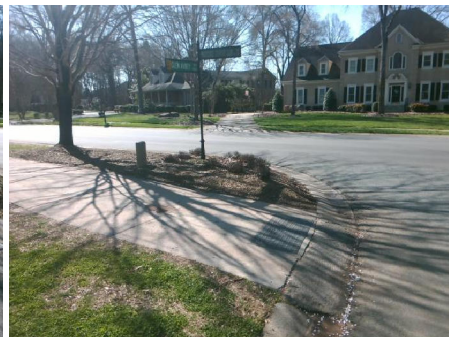
| Codes/Mitigation Info/Possible Solution | | | Field Measurements/Component Compliance | | | | | | |
|--|---|--|--|---|---|---|---|---|---|
| | PROW/ADA: | | Not Found, R304.5.3 | | | | | | |
| | | | Yes | Ramp Width (in) | 48.0 | No | Ramp XSlope (%) | 2.2 | |

| Codes/Mitigation Info/Possible Solution | | | Field Measurements/Component Compliance | | | | | | |
|--|---|--|--|---|---|---|---|---|---|
| | Possible Solutions: | | Remove & Replace Entire Ramp. | | | | | | |
