# Access Compliance Report

## Public Rights-of-Way

### (Curb Ramps)

| Intersection ID: 48305 | Main Street: MCDONALD_RD | Cross Street: GANSO_LN | Location: NE |

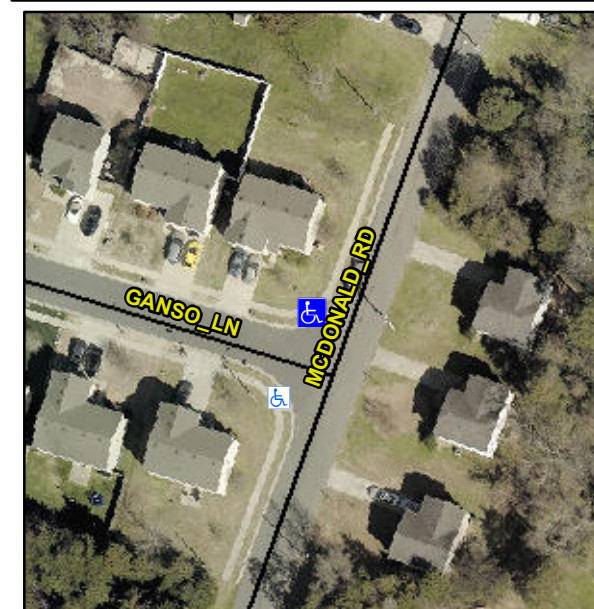
| ADA ID: CB41E0E0966F | Ramp Type: Perp | Initial Pass/Fail: Fail | Overall Compliance: No |
| Severity Score: 13.75 | | | |

**Not Found, R304.2.2, R304.5.3**

| Compliance | Description | Data | Compliance | Description | Data |
|---|---|---|---|---|---|
| N/A | Ramp Length (in) | 48.5 | No | Ramp Slope (%) | 11.3 |
| Yes | Ramp Width (in) | 48.0 | No | Ramp XSlope (%) | 4.5 |

**Remove & Replace Entire Ramp.**
