Access Compliance Report

Public Rights-of-Way

(Curb Ramps)

Intersection ID: 11331	Main Street: E_W_T_HARRIS_BV	Cross Street: MEADOW_ROSE_LN	Location: NE
ADA ID: CC83804AEB1E	Ramp Type: Combination1	Initial Pass/Fail: Fail	Overall Compliance: No
			Severity Score: 18.75

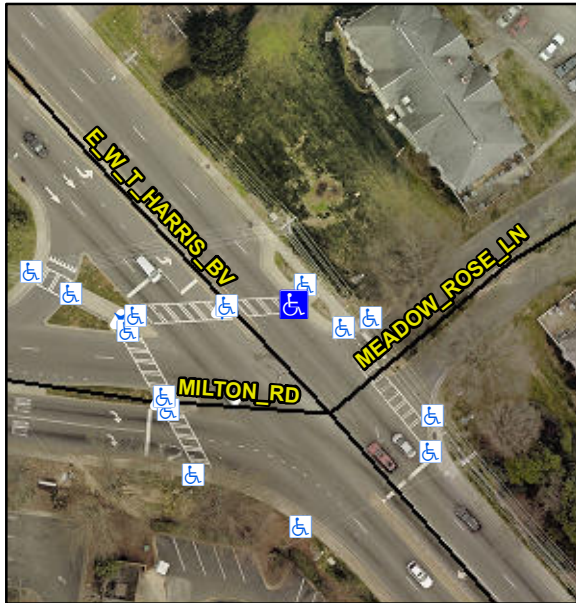
RT RP < 5%

Not Found, R304.5.1, R304.5.3

Compliance	Description	Data	Compliance	Description	Data
N/A	Ramp Length LT (in)	71.0	N/A	Ramp Length RT (in)	68.5
No	Ramp Width LT (in)	34.5	No	Ramp Width RT (in)	34.5
Yes	Ramp Slope LT (%)	7.1	Yes	Ramp Slope RT (%)	2.9
No	Ramp XSlope LT (%)	2.6	Yes	Ramp XSlope RT (%)	1.8
N/A	Ramp Length (in)	25.0	Yes	Ramp Slope (%)	4.4
Yes	Ramp Width (in)	48.0	No	Ramp XSlope (%)	2.3
N/A	Flare Type LT	N/A	N/A	Flare Type RT	N/A
N/A	Flare Slope LT (%)	N/A	N/A	Flare Slope RT (%)	N/A
N/A	Flare Traversable LT?	N/A	N/A	Flare Traversable RT?	N/A
N/A	Landing Length (in)	N/A	N/A	DWS Provided?	N/A
N/A	Landing Width (in)	N/A	N/A	DWS Contrast?	N/A
N/A	Landing Slope (%)	N/A	N/A	DWS Length (in)	N/A
N/A	Landing X Slope (%)	N/A	N/A	DWS Full Width?	N/A
N/A	Landing Curb? (Y/N)	N/A	N/A	DWS Offset (in)	N/A
N/A	Shared Landing?	N/A			
N/A	Gutter Ponding?	N/A	N/A	Gutter Slope (%)	N/A
N/A	Gutter Lip Ht (in)	N/A	N/A	Gutter X Slope (%)	N/A
N/A	Painted X Walk1?	Yes	N/A	Painted X Walk2?	N/A

Remove & Replace Entire Ramp.
