# Access Compliance Report

## Public Rights-of-Way

| Intersection ID: 11480 | Main Street: N_CEDAR_ST | Cross Street: W_5TH_ST | Location: E |
| ADA ID: CD67A5B163BD | Ramp Type: PerpDiag | Initial Pass/Fail: Fail | Overall Compliance: No |

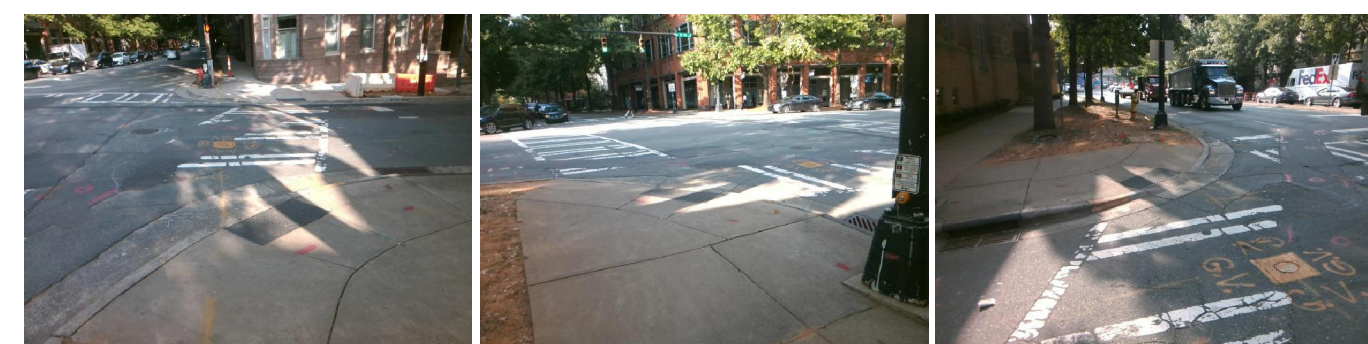
**Not Found, R304.5.1, R304.5.3**

| Compliance | Description | Data | Compliance | Description | Data |
|---|---|---|---|---|---|
| No | Ramp Width (in) | 32.0 | No | Ramp XSlope (%) | 11.1 |

**Remove & Replace Curb Ramp With Two New Directional Ramps or Equivalent.**
