# Access Compliance Report

## Public Rights-of-Way

### (Curb Ramps)

Intersection ID: 13781	Main Street: MAYBERRY_LN	Cross Street: ROBINWOOD_DR	Location: NW
ADA ID: CD69C4895DB3	Ramp Type: Perp	Initial Pass/Fail: Fail	Overall Compliance: No
			Severity Score: 13.75

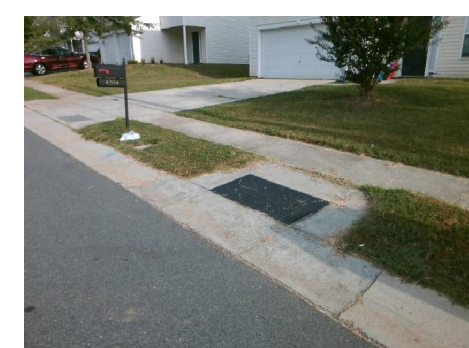
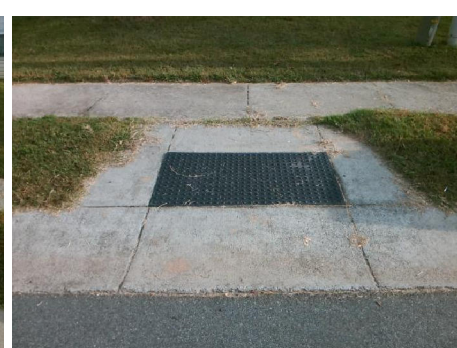
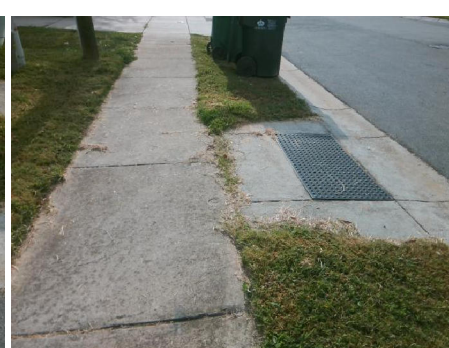
Possible Solutions:		<b>Compliance</b>	<b>Description</b>	<b>Data</b>
	<b>Remove &amp; Replace Entire Ramp.</b>		<b>No</b>	Ramp Length (in)	47.0
			<b>Yes</b>	Ramp Width (in)	48.0
			<b>N/A</b>	Flare Type LT	N/A
			<b>N/A</b>	Flare Slope LT (%)	N/A
			<b>N/A</b>	Flare Traversable LT?	N/A
			<b>N/A</b>	Landing Length (in)	N/A
			<b>N/A</b>	Landing Width (in)	N/A
			<b>N/A</b>	Landing Slope (%)	N/A
			<b>N/A</b>	Landing X Slope (%)	N/A
<p>Surveyor Notes:</p> <p><b>N/A</b></p> <p>PROW/ADA:</p> <p><b>Not Found, R304.2.2</b></p>			<b>N/A</b>	Flare Type RT	N/A
			<b>N/A</b>	Flare Slope RT (%)	N/A
			<b>N/A</b>	Flare Traversable RT?	N/A
			<b>N/A</b>	DWS Provided?	N/A
			<b>N/A</b>	DWS Contrast?	N/A
			<b>N/A</b>	DWS Length (in)	N/A
			<b>N/A</b>	DWS Full Width?	N/A
			<b>N/A</b>	DWS Offset (in)	N/A
			<b>N/A</b>	Shared Landing?	N/A

<b>N/A</b>	Gutter Ponding?	N/A
			<b>N/A</b>	Gutter Lip Ht (in)	N/A
			<b>N/A</b>	Painted X Walk1?	No
				X Walk 1 Direction	To S
			<b>N/A</b>	X Walk 1 Width (in)	N/A
				X Walk 1 Slope (%)	0.8
				X Walk 1 X Slope (%)	2.4
			<b>N/A</b>	Ramp inside XWalk1?	N/A
			<b>N/A</b>	Road Slope (%)	N/A
			<b>N/A</b>	Road X Slope (%)	N/A
			<b>N/A</b>	Any Obstructions?	N/A
Total Cost:		\$ 1850.00		Obstruction Type	
			<b>N/A</b>	Clear Space?	N/A
			<b>N/A</b>	Clear Space to XWalk (in)	N/A
			<b>N/A</b>	Storm Grate/Utility Hazard?	N/A
				Storm Grate/Utility Type	
			<b>N/A</b>		N/A
			<b>Yes</b>	Surface Condition? (G/P)	Good
