Access Compliance Report

Public Rights-of-Way

(Curb Ramps)

Intersection ID: 10029213	Main Street: JOHN_PRICE_RD	Cross Street: N/A	Location: NE
ADA ID: CDE6E03DD877	Ramp Type: Combination1Diag	Initial Pass/Fail: Pass	Overall Compliance: No
		Severity Score: 15

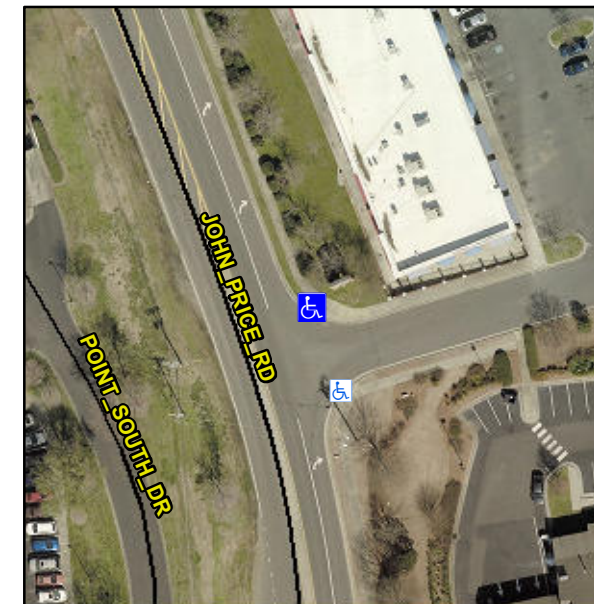
MEDIAN ACROSS JOHN PRICE RD, RT RP < 5%

Not Found, R304.5.3, R304.2.1, R304.2.2-Perp, R304.3.2-Para, R305, R304.5.4

Compliance	Description	Data	Compliance	Description	Data
N/A	Ramp Length LT (in)	55.0	N/A	Ramp Length RT (in)	64.0
Yes	Ramp Width LT (in)	60.0	Yes	Ramp Width RT (in)	60.0
Yes	Ramp Slope LT (%)	6.1	Yes	Ramp Slope RT (%)	1.5
No	Ramp XSlope LT (%)	2.1	Yes	Ramp XSlope RT (%)	1.9
N/A	Ramp Length (in)	51.0	Yes	Ramp Slope (%)	6.7
Yes	Ramp Width (in)	54.0	No	Ramp XSlope (%)	4.6
N/A	Flare Type LT	Sloped	N/A	Flare Type RT	Sloped
N/A	Flare Slope LT (%)	10.6	Yes	Flare Slope RT (%)	2.6
N/A	Flare Traversable LT?	No	N/A	Flare Traversable RT?	Yes
Yes	Landing Length (in)	60.0	No	DWS Provided?	No
No	Landing Width (in)	42.5	N/A	DWS Contrast?	No
No	Landing Slope (%)	2.6	N/A	DWS Length (in)	N/A
No	Landing X Slope (%)	2.3	N/A	DWS Full Width?	No
N/A	Landing Curb? (Y/N)	No	N/A	DWS Offset (in)	N/A
N/A	Shared Landing?	No			
Yes	Gutter Ponding?	No	No	Gutter Slope (%)	7.5
Yes	Gutter Lip Ht (in)	0.0	No	Gutter X Slope (%)	2.1
N/A	Painted X Walk1?	No	N/A	Painted X Walk2?	No

X Walk 1 Direction	To W		X Walk 2 Direction	To S
	X Walk 1 Width (in)	N/A		X Walk 2 Width (in)	N/A
	X Walk 1 Slope (%)	2.0		X Walk 2 Slope (%)	1.4
	X Walk 1 X Slope (%)	0.6		X Walk 2 X Slope (%)	2.1
N/A	Ramp inside XWalk1?	N/A	N/A	Ramp inside XWalk2?	N/A
	Road Slope (%)	0.8		Clear Space?	Yes
	Road X Slope (%)	2.6	N/A	Clear Space to XWalk (in)	N/A
			Yes	Any Obstruction?	No
				Obstruction Type	N/A
			Yes	Storm Grate/Utility Hazard?	No
				Storm Grate/Utility Type	N/A
			Yes	Surface Condition? (G/P)	Good
				Curb Slope (%)	11.6

Remove & Replace Curb Ramp With Two New Directional Ramps or Equivalent. Remove & Replace Gutter.
