Access Compliance Report

Public Rights-of-Way

(Curb Ramps)

Intersection ID: 49791	Main Street: BAHIA_LN	Cross Street: BARLEY_LN	Location: S
ADA ID: CE6567974449	Ramp Type: Perp	Initial Pass/Fail: Fail	Overall Compliance: No
Severity Score: 8.75			
Codes/Mitigation Info/Possible Solution		Field Measurements/Component Compliance

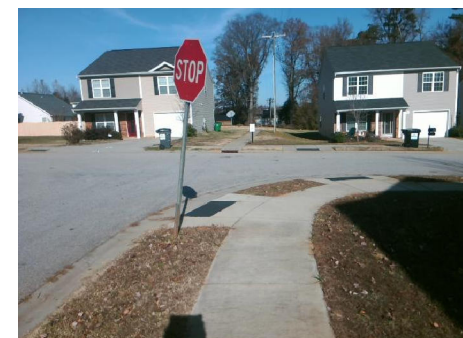
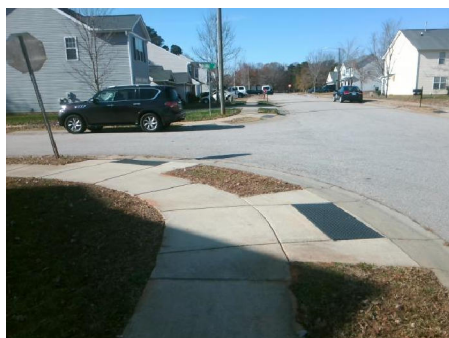
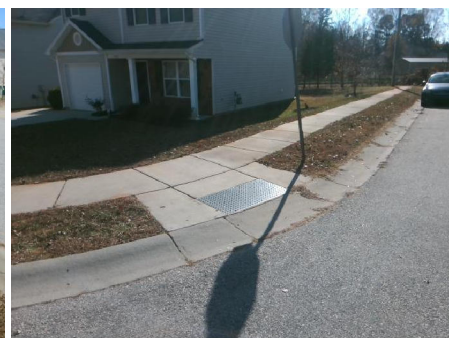
Not Found, R304.5.1

Compliance	Description	Data	Compliance	Description	Data
N/A	Ramp Length (in)	49.0	Yes	Ramp Slope (%)	5.4
No	Ramp Width (in)	46.5	Yes	Ramp XSlope (%)	0.9
N/A	Flare Type LT	N/A	N/A	Flare Type RT	N/A
N/A	Flare Slope LT (%)	N/A	N/A	Flare Slope RT (%)	N/A
N/A	Flare Traversable LT?	N/A	N/A	Flare Traversable RT?	N/A
N/A	Landing Length (in)	N/A	N/A	DWS Provided?	N/A
N/A	Landing Width (in)	N/A	N/A	DWS Contrast?	N/A
N/A	Landing Slope (%)	N/A	N/A	DWS Length (in)	N/A
N/A	Landing X Slope (%)	N/A	N/A	DWS Full Width?	N/A
N/A	Landing Curb? (Y/N)	N/A	N/A	DWS Offset (in)	N/A
N/A	Shared Landing?	N/A			
N/A	Gutter Ponding?	N/A	N/A	Gutter Slope (%)	N/A
N/A	Gutter Lip Ht (in)	N/A	N/A	Gutter X Slope (%)	N/A
N/A	Painted X Walk1?	No	N/A	Painted X Walk2?	N/A
	X Walk 1 Direction	To NW		X Walk 2 Direction	N/A
N/A	X Walk 1 Width (in)	N/A	N/A	X Walk 2 Width (in)	N/A
	X Walk 1 Slope (%)	2.3		X Walk 2 Slope (%)	N/A
	X Walk 1 X Slope (%)	1.3		X Walk 2 X Slope (%)	N/A

N/A	Ramp inside XWalk1?	N/A	N/A	Ramp inside XWalk2?	N/A
	Road Slope (%)	N/A	N/A	Clear Space?	N/A
	Road X Slope (%)	N/A	N/A	Clear Space to XWalk (in)	N/A
N/A	Any Obstructions?	N/A	N/A	Storm Grate/Utility Hazard?	N/A
	Obstruction Type			Storm Grate/Utility Type	
		N/A			N/A
			Yes	Surface Condition? (G/P)	Good

Possible Solutions:

Remove & Replace Entire Ramp.
